SAFETY ALERT

INCIDENT	Truck Driver fall from height
SUBJECT	Working in isolation at height
INCIDENT DATE	12-08-2019
BUSINESS UNIT	Humes – Hastings Manufacturing

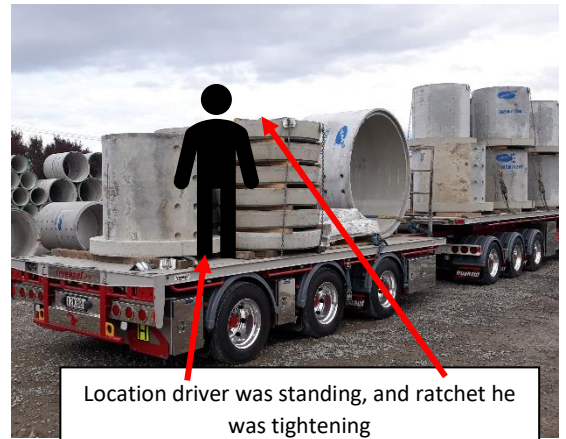
At about 13:30 Monday afternoon, a truck driver (external freight provider) at the Humes Hastings manufacturing site was on the deck of his truck tightening a ratchet, when the ratchet handle gave way. As a result, he lost his balance, and fell off the rear of the truck.

Location driver was standing, and ratchet he was tightening

- Ratchet ties should always be positioned to be fastened and released from the ground.
- If you have to climb to height, how are you preventing yourself from falling?

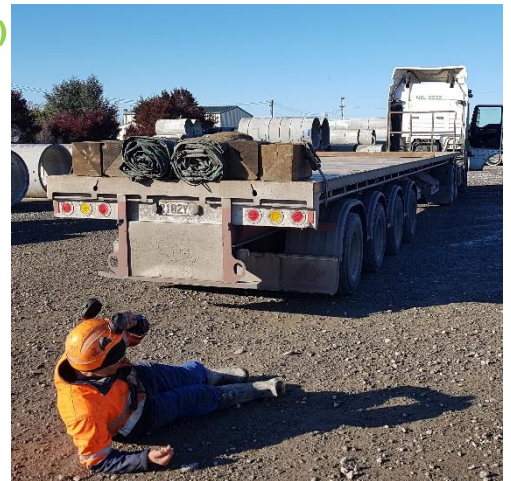
The driver fell down, landing fully on his right arm, which broke his wrist, and forced his arm in such a way, that it cracked his ribs, with one of the ribs puncturing his lung.

Location where driver was lying after he fell (re-enactment)
