Package / Contract	RDP North - Scotswood to North Brunton	Location	A1 North of Jct77 southbound
Date & Time	11 October circa 12:15pm	Incident Type	Smashed Dumper Windscreen

Outline of Incident

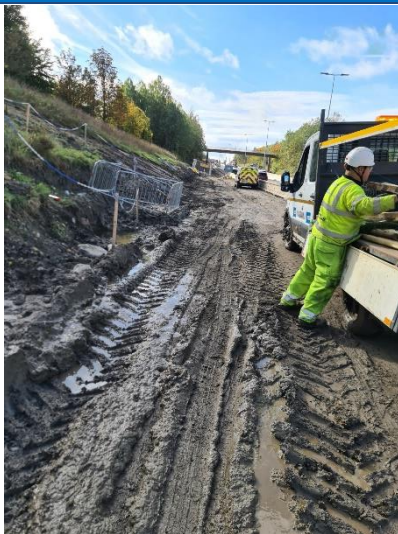
On Monday 11 October 2021 at circa 12 noon, a Costain pickup was stuck adjacent to the haul road within the verge working area on the southbound side. A decision was made to use a supply chain dumper to 'push' the Costain pickup out of the area it was stuck in. The individuals involved decided to use two 300mm pieces of 4"x2" timber between the dumper and pick up as an aide in the attempt to push the pickup clear. The timber has sprung free and smashed the front windscreen glass of the dumper. Once it was established that no one was hurt, the pickup was pushed out manually.

Area just off haul road where vehicle became stuck

- ✓ Haul road in that area repaired and improved for clear lines between road and verge.
- ✓ All on site instructed not to attempt to carry out actions that are not covered by an appropriate RAMS.
- ✓ Full inspection of all other haul road areas within verges on the project.
- ✓ Specific maintenance team dedicated to maintenance of all haul roads.

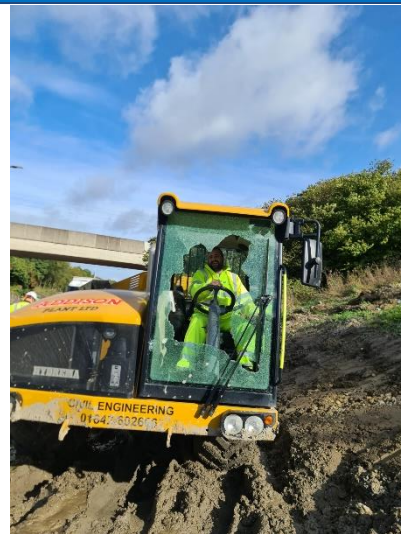
Smashed windscreen on dumper
