NZ Safety Alert

23 April 2021

Snatch block failure during lift

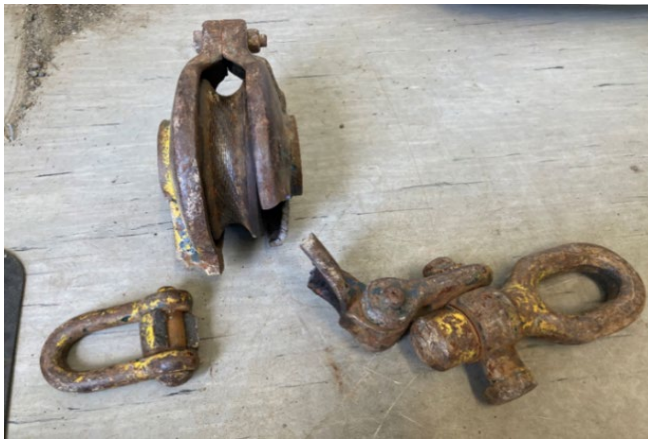
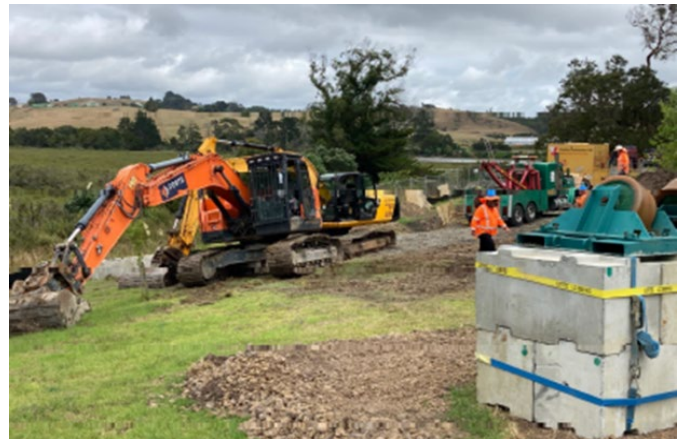
A contractor was engaged to remove an 18m x 1050mm casing from a trench using a winch truck. The rope was rigged to an excavator through a snatch block to the casing, and then through a second snatch block and anchored to the excavator.

As the full weight came on during the lift, the first snatch block in the line broke, sending the body of the block back towards the winch operator and hitting a temporary fence base block. This forced the base block onto the winch operators foot causing a compound fracture of the foot.

1. Exclusion zones are established for every lift to ensure no-one is in the fall zone or line of fire.
2. All lifting equipment is checked as fit for purpose prior to use in a lift.
3. You always use the correct equipment for every lift e.g., load cells, shackles, snatch blocks, slings, chains etc.
