NZ Safety Alert

July 2019

Split fuel hose covers worker

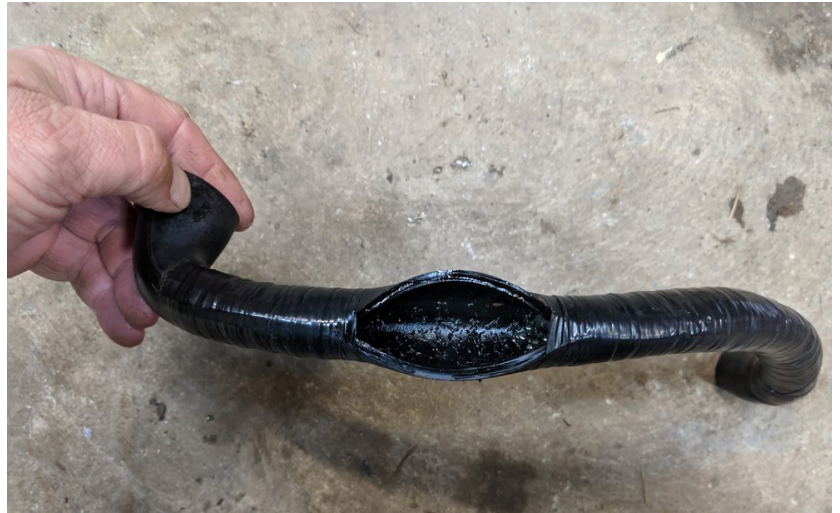
A worker was refueling his forklift when the hose on the diesel bowser split spraying diesel over his head, face and top part of his body.

The above ground fuel tank is hired. When the owner of the tank was contacted to ask what checks they carried out, and to request a new hose, they did not even know this company had one of their tanks.

1. Regular and appropriate checks are made of all fuel tanks, hoses and dispensing units.
2. Where relying on contractors or others to do checks and maintenance, regular inspections are conducted to ensure maintenance is carried out correctly.
3. Fuel and diesel are included in hazardous substance inventories and Safety Data Sheets are available to workers.
4. Appropriate washing facilities are available on site in the event that workers are exposed to hazardous substances.
