# NZ Safety Alert

31 March 2023

## Truck body hits conveyor

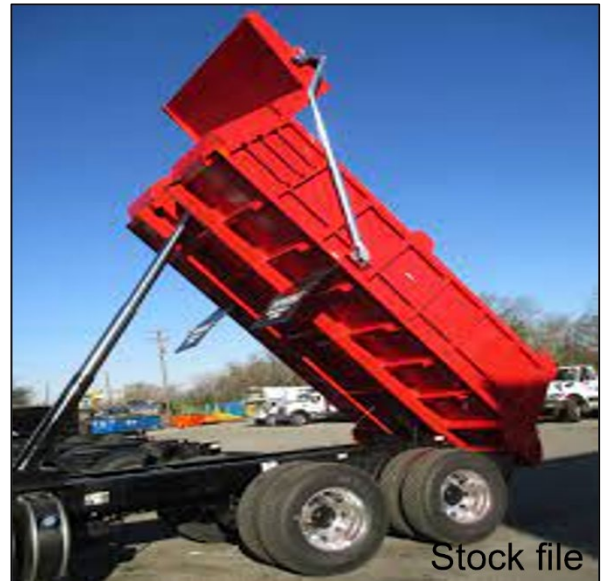
A quarry truck left the wash out area with the hoist up and headed to the dust bin area.

In transit, while talking over the RT, the operator became distracted and failed to lower the hoist.

The raised deck came into contact with the overhead advanced height warning indicator and subsequently struck an overhead conveyor.

No injuries were sustained during this incident.

1. Trucks have suitable warning devices to alert a driver to the fact that the hoist has not been lowered.
2. Overhead structures are clearly marked and signposted to alert mobile equipment operators.
3. All mobile plant operators are trained and assessed as competent to operate mobile equipment.
