NZ Safety Alert

Uncontrolled stored energy release

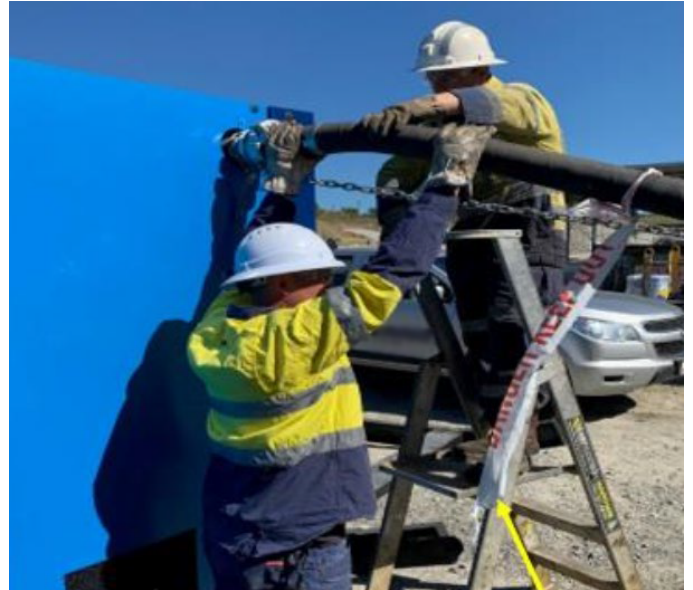
Two contractors asked to remove a compressor from a delivery pallet, noticed that a 100ml air line was attached to the compressor and connected to the site's air system.

Having identified the potential for air pressure in the line, they isolated the valve on the air system and opened the valve located on the compressor. No air was released, and the contractors began disconnecting the air line from the compressor.

As the connector reached the release point, the hose released suddenly forcing it down past the head of the contractor working from the ground.

The resulting air blast blew the contractors helmet and glasses off with the helmet landing approximately 25 metres away and the glasses landing on top of the compressor housing.

1. All pressure is released prior to working on any pressurised equipment. Checks should be done to ensure no pressure exists in any line or vessel.
2. You check all pressure vessels, including compressors, have end user pressure relief valves fitted.
3. Relief valves are fitted to any permanent fixed compressors if no other way is identified for relieving pressure from attached systems.
