NZ Safety Alert

Unintentional movement of light vehicle

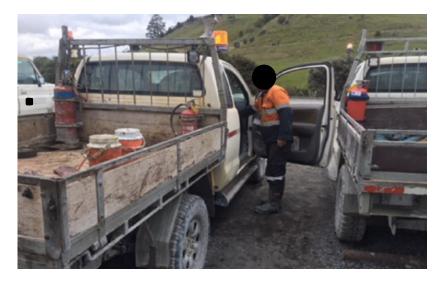
A worker was conducting a pre-start on a light vehicle (LV). The LV was parked in reverse gear with the handbrake on. The offsider was standing outside the vehicle with the door open and reached in to turn the key to the on position, so that he could check the indicators. He has unintentionally turned the key to the start position which started the LV. The LV then travelled in reverse until it contacted a concrete stop log approximately 1.5 metres behind and the offsider then managed to switch the key off. During the reversing movement of the LV, the driver's door caught on an

adjacent LV and was bent forward. No injuries were sustained, however as the location of the incident has a high frequency of pedestrian movement, there was potential for serious injury.

- You review LV parking areas to eliminate congestion and ensure pedestrians are not exposed to the risks associated with uncontrolled vehicle movements.
- Where possible have clutch/ignition interlocks fitted to site light vehicles with manual transmissions that do not have sealed wet brake systems (SIBS) fitted.
- You review pre-start procedures for LVs to ensure they comply with Original Equipment Manufacturer (OEM) recommendations, including ensuring vehicles are fundamentally stable when parked.
- All workers are trained and assessed as competent to conduct pre-start checks on all vehicles including LVs.
