NZ Safety Alert

8 September 2023

Unintended movement of work basket

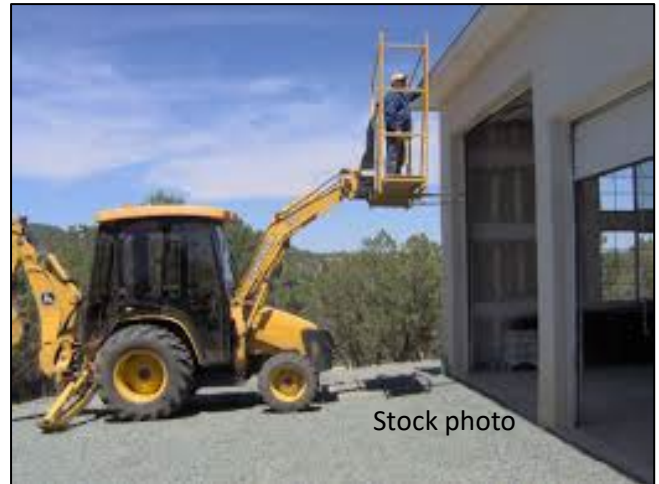
An electrician was working in a work basket attached to an integrated tool carrier (IT). As the operator of the IT leant forward on the seat to better observe the basket, his seat lifted vertically due to the reduction in weight, and the operator made contact with the touch screen controls.

The boom height adjustment lever was pushed back, resulting in an uncontrolled upward movement of the basket.

The electrician crouched down in the basket in response to the unexpected upward movement and in doing so, in combination with the crush protection bar, avoided injury.

1. All operators of mobile equipment are trained and assessed as competent to operate that equipment.
2. Any objects in cabins or mobile equipment, whether Original Equipment Manufacturer or after market, that have the potential to interfere with controls are addressed prior to operation of that equipment.
3. Fit-for-purpose equipment is used for all tasks.
4. All work baskets have basket crush protection systems installed.
