Worker falls from height

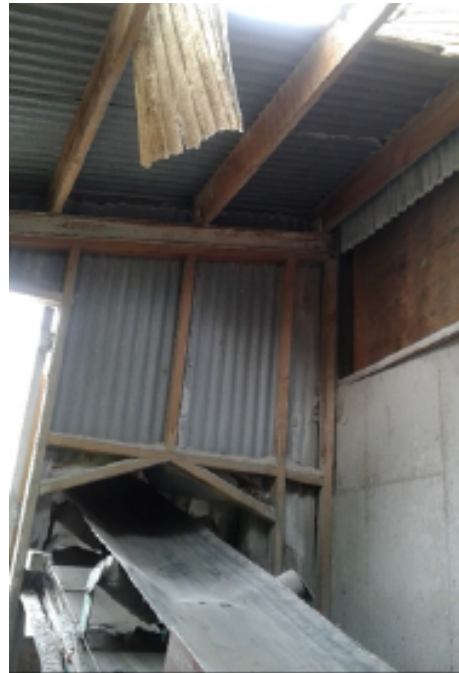
A contractor was working on a roof when he stepped onto a brittle clearlite panel and fell 2.5metres onto the conveyor below. The worker was wearing the correct fall restraint harness, which was correctly anchored. He had, however, failed to tension the rope grab, thus impacting on the restraint system's ability to restrain him.

We recommend that all sites review tasks that cannot be completed on solid ground and any working at height activities. You need to ensure that:

- **There is safe and adequate access to all areas of the plant where maintenance is carried out**
- **Clearlite panels and other unstable surfaces are covered to provide a stable working surface where access is required for maintenance or other activities**
- **Risk assessments are completed on all non-routine tasks to ensure that hazards are identified, risks assessed and effective controls are put in place**
- **Regular workplace inspections are conducted to ensure that risk controls are in place and are effective**
- **All workers are trained, and regularly re-trained, in Working at Heights procedures and the correct use of fall restraint equipment.**
