NZ Safety Alert

5 March 2021

Worker sprayed with battery acid

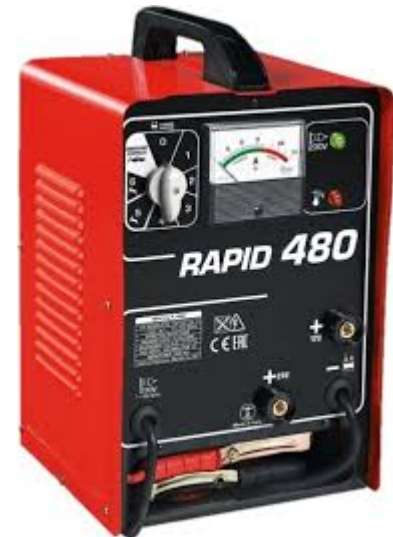
The crew switched the excavator off when they took a break and upon return the excavator would not start. They plugged into the charger again and after an hour on charge, the operator turned the main isolator to the "on" position and the battery exploded.

Battery acid sprayed onto the right side of his body and face. The operator had full Personal Protective Equipment (PPE) and experienced no serious injuries.

1. Workers are aware of safe operating procedures for charging batteries, and jump-starting batteries on equipment.
2. Batteries are regularly checked to ensure terminals and clamps are not oxidized, battery caps can vent to prevent build-up of gases, and there is enough electrolyte to cover terminals to prevent sparks.
3. Suitable and appropriate PPE is used when operating plant and equipment.
