NZ Safety Alert

September 2019

Failure of seatbelt bracket

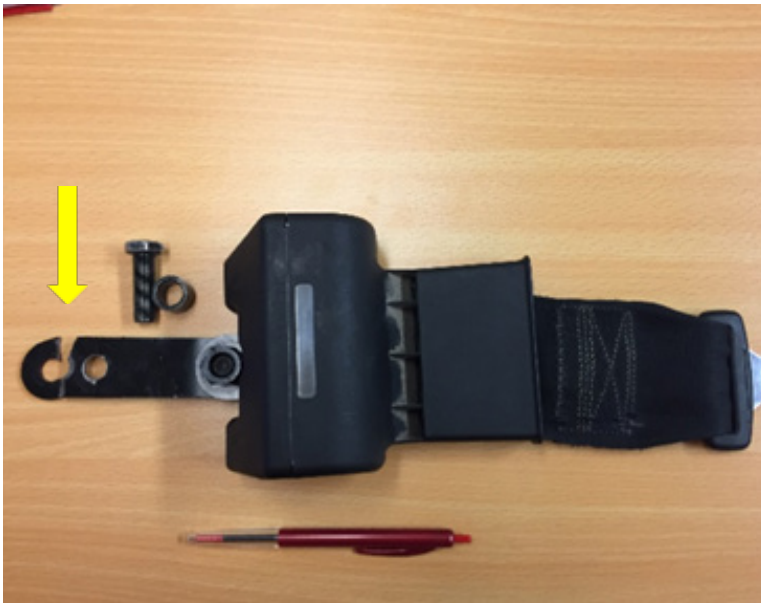
A late model loader was operating at a sand quarry. The operator of the loader drove into the sand stockpile to load his bucket. As he did so the seatbelt bracket failed, and the operator was flung forward striking his head against the cab roof and windscreen. Fortunately, the operator only received a minor neck muscle strain in the incident.

The loader is less than a year old and the seatbelt is otherwise in good condition. The distributor of the equipment was notified, and they are conducting a full investigation into the failure.

In the short term all loader seatbelt assemblies have been visually inspected by a competent person.

1. As part of regular maintenance, seatbelt assemblies and securing brackets are visually checked by a suitably qualified person.
2. Operators are trained and assessed as competent to operate mobile equipment, including pre-start inspections which should include seatbelt assemblies and brackets.
3. Seatbelts are worn at all times. You may need to consider consequences for those caught not wearing seatbelts.
4. Plant should be locked out and not used if seatbelt assemblies and/or brackets are faulty and unable to be used properly.
