Safety Bulletin

Fires on battery powered tools increase

This safety alert provides safety advice for the NSW mining industry.

Safety Bulletin SB22-17

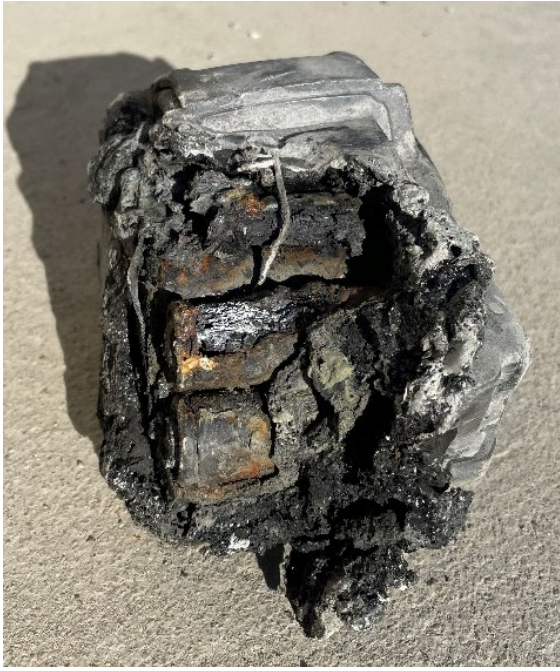
Figure 1 - Damage to battery after being run over

- Only use charging equipment recommended by the manufacturer for that particular battery.
- Ensure that transporting of spare batteries does not expose them to risk of physical damage or short circuit of the connecting pins.
- Do not expose batteries to water as this can cause a short circuit between the battery connections.
- Do not expose batteries to temperatures greater than 50°C, or as recommended by the manufacturer. It should be noted that temperatures inside a vehicle can be much greater than external ambient temperatures. For example, the internal temperature of a vehicle left with
