NZ Safety Alert

16 February 2024

Worker burnt during maintenance

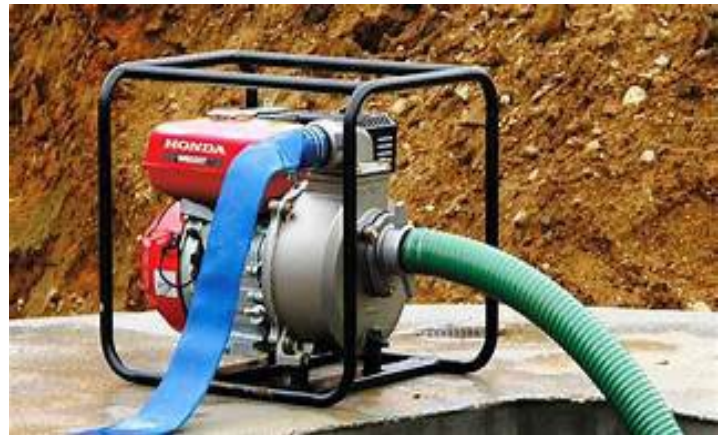
A worker was attempting to clear a blockage in a water pump at an alluvial gold mine when a hose separated from the pump, spraying the worker with scalding hot water.

The incident is currently under investigation but it appears that the pump was operating whilst the worker tried to clear the blockage.

1. That all plant is de-energised and pressure released prior to conducting maintenance on that plant.
2. Hoses containing pressure are securely attached to pumps etc, and whip chains or other safety devices are attached to contain hoses in the event of unplanned separation.
3. All plant and equipment are maintained in accordance with Original Equipment Manufacturers (OEM) requirements.
