MinEx
Health and Safety in NZ extractives

Safety Alert

20 November 2026

Working at height breach

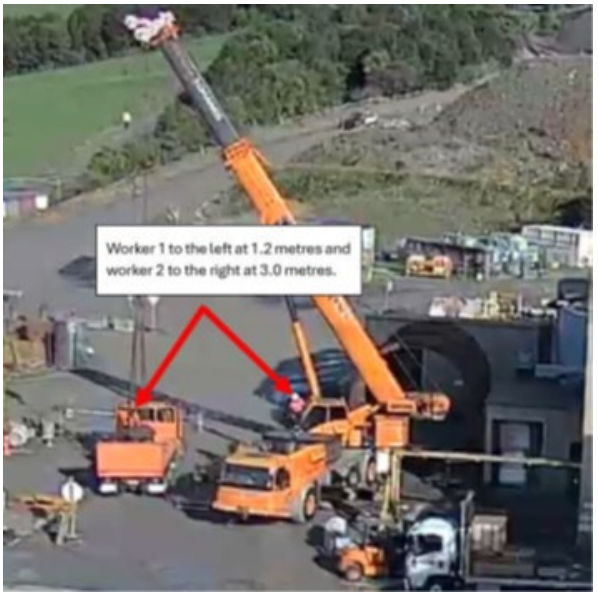
During the setup of a crane on site, a contractor was observed on top of the counterweights without fall protection.

The worker was within two metres of an unprotected edge, exposing himself to a potential three-metre fall to the ground.

1. Regular supervision of contractors is conducted to verify that they are complying with your safety management system requirements.
2. All workers, including contractors, are trained and assessed as competent to work at heights.
3. Adequate controls to prevent falls from height are in place before conducting any working at heights task.
