**NSW  
Resources  
Regulator**

# **Workers trapped in shaft winder**

Causal investigation

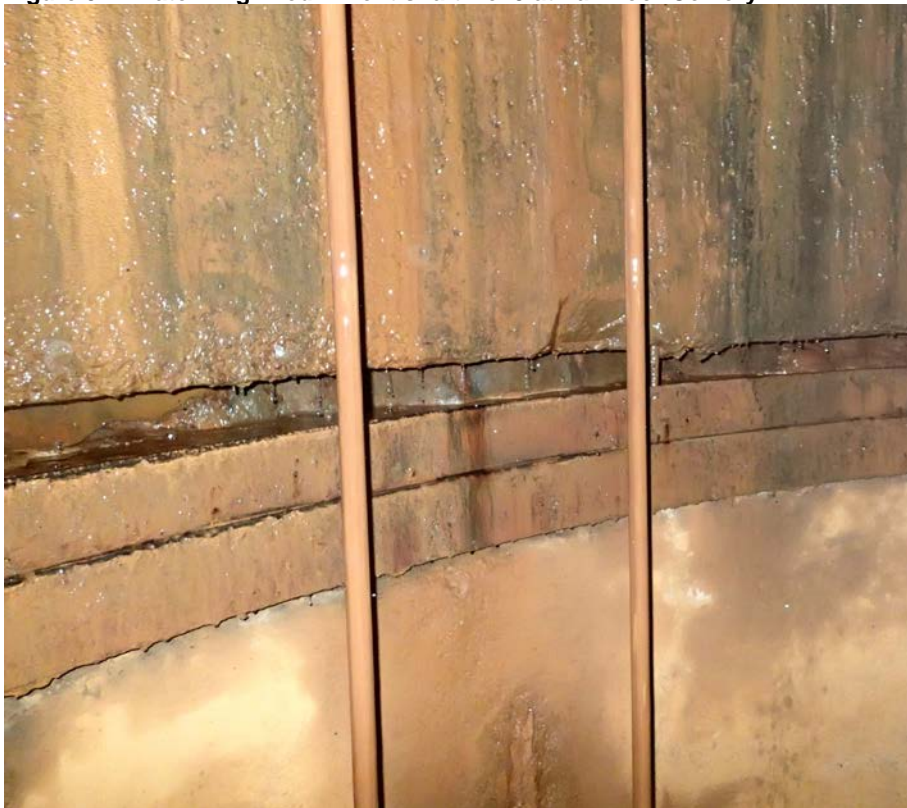
On 5 September 2018, conditions in the shaft were considered normal. The No. 3 ventilation shaft was delivering 127 metres<sup>3</sup> per second fresh air to the mine at the time of the incident. Maximum temperature variances in the shaft were estimated at  $\pm 15^{\circ}\text{C}$  and the estimated temperatures on the night of the incident were between  $5^{\circ}\text{C}$  and  $10^{\circ}\text{C}$ . Water make in the shaft was via underground aquifers and influenced by local rainfall. Water was collected in the shaft via a series of gutters (known as water rings) and transferred to the base of the shaft through a series of downpipes, where it was pumped from the mine. Figure 5 depicts a water ring fixed in the No. 3 shaft at Tahmoor Colliery.

**Figure 5. A water ring fixed in vent shaft No. 3 at Tahmoor Colliery.**
