**NSW
Resources
Regulator**

Investigation report

The death of Mark Siegel at mineral claim 44507 near
Lightning Ridge on 4 November 2016

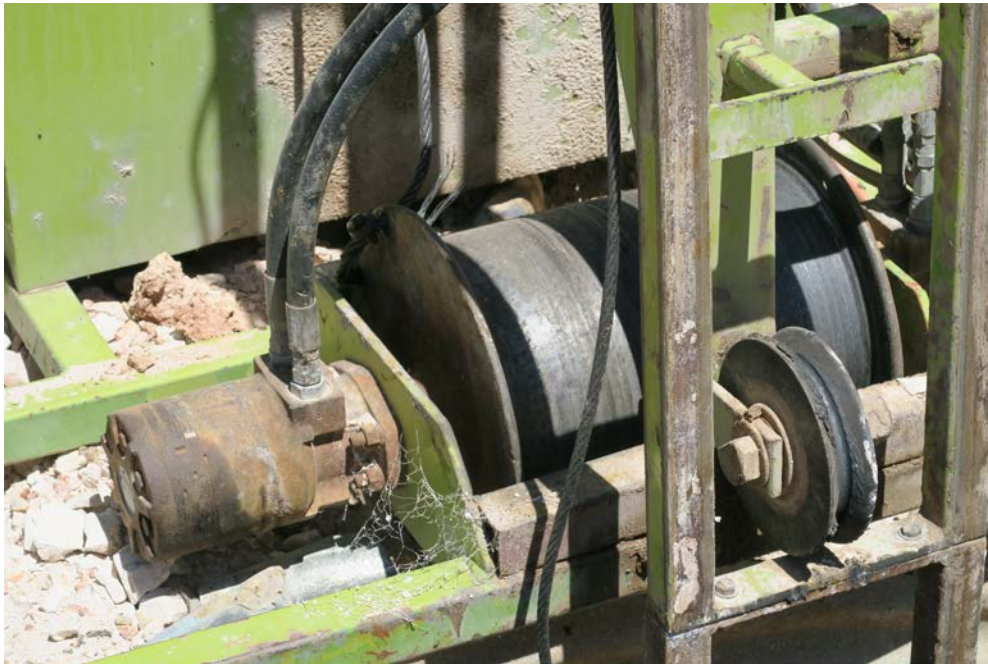
Figure 7: Hoists drum and cable.

Mullock is trammed to the bucket using a bogger (figure 5). The mullock is deposited into the hoist bucket and raised to the surface by activating the start button on the lower control panel (figure 6). A steel cable attached to the bucket and drum (via a U clamp) winds around the hoist's drum (figure 7) in an under-wrap position when the bucket is raised to the surface (figure 8).

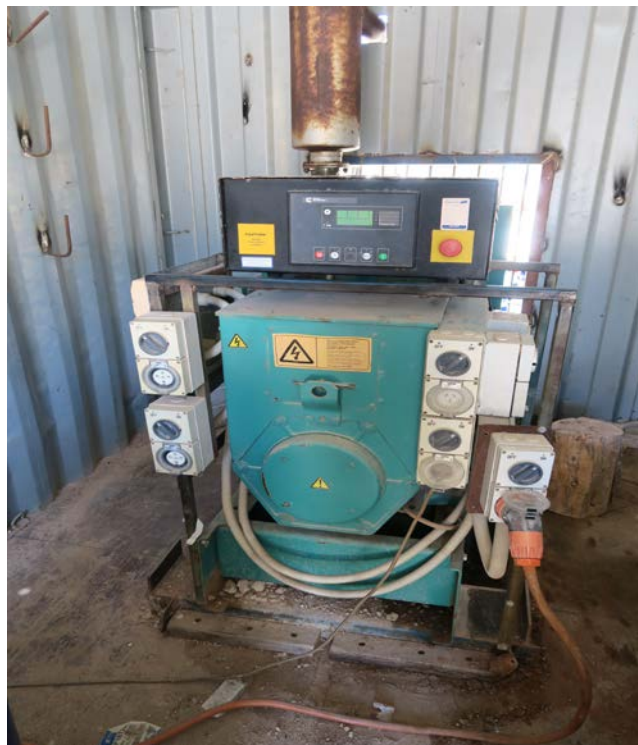
The hoist was powered by a 240/415 volt Cummins Power Generator model ES62.5 (S/N 301141) in a shipping container near the super hoist (figure 12). The generator uses diesel fuel. The generator was made in Singapore with a manufacture date of 2003.

Figure 12: The generator that powers the electric motor to the hydraulic system and underground lights.

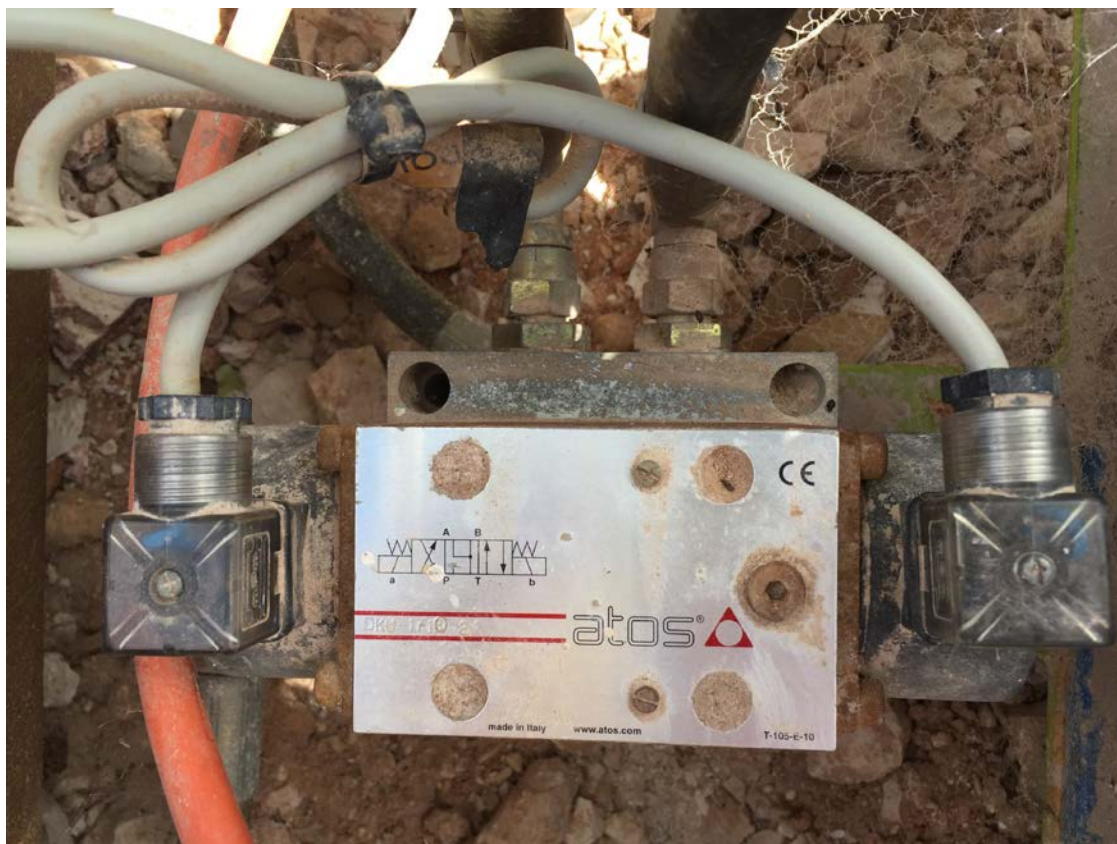
Figure 14: The Atos solenoid valve.

The solenoid valve was manufactured by Atos (Italy) and imported and distributed in Australia by Southcott Pty Ltd (figure 14). The original valve model was number DKU-1713-X-00 (figure 15), however at some point it was converted by person(s) unknown to model DKU-1710-X-00 (figure 16). Examination of the valve revealed a new model number was stamped over the original number. The manufacturer of the hoist, Ag-Fab Pty Ltd, bought a large number of items, including solenoid valves, hoses and other equipment from Southcott Pty Ltd over several years.

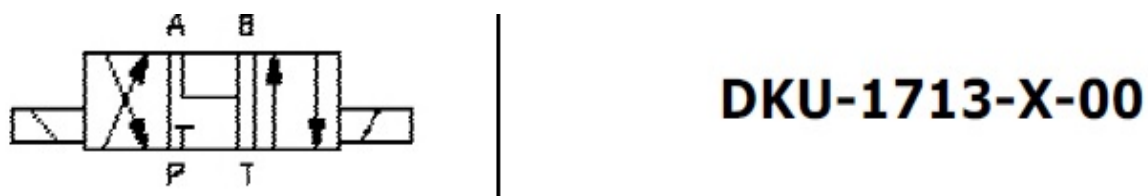
Figure 15: Solenoid valve configuration before conversion.

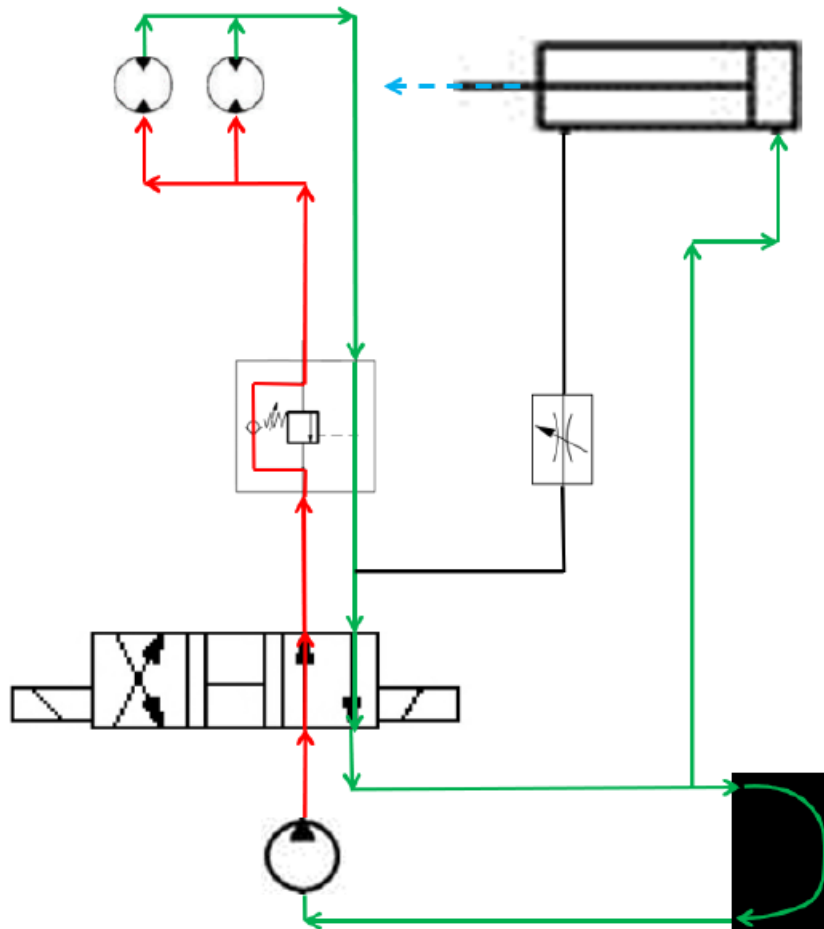
Figure 17: The solenoid valve during the hoist lift sequence.

The valve is a three-position, four-port valve that directs the flow of oil through the hydraulic system. The valve generally remains in the centre position and when the hoist bucket is activated to rise, the valve moves left, engaging the far right port with the up-down arrows (figure 17).

When this occurs, the hoist's hydraulic oil is being pumped, under pressure, through the system as shown in figure 17. When power is lost, the solenoid valve returns to the centre or rest position.

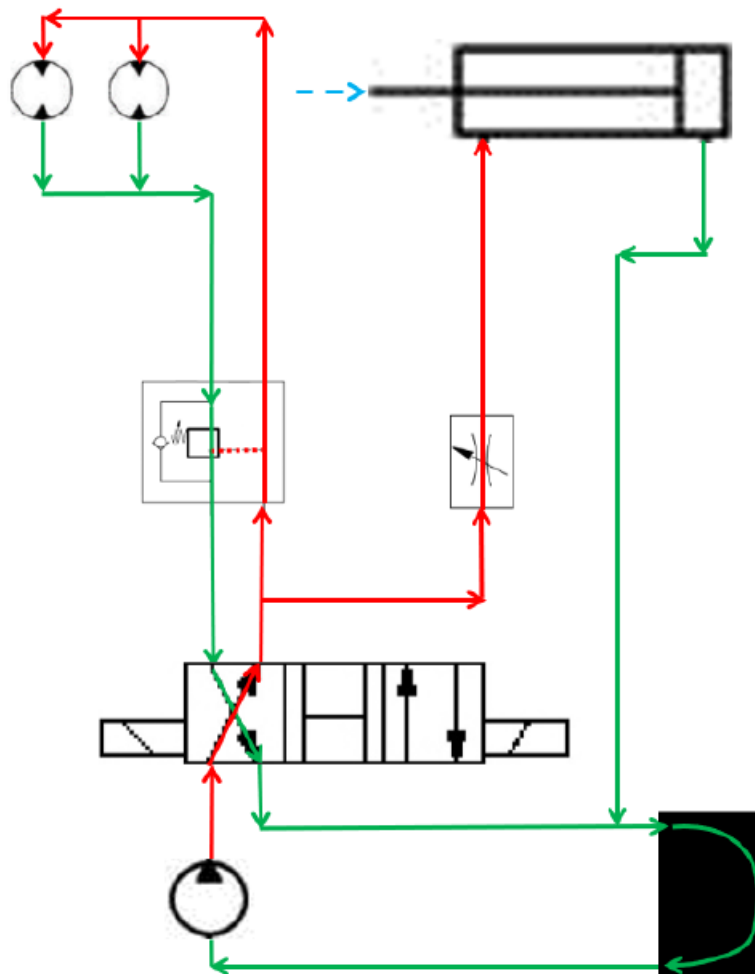
Figure 18: The solenoid valve during the hoist lowering sequence.

The limit switch on the arc at the top of the hoist signals the solenoid (figure 14). The valve then moves right, engaging the far left port with the arrows that cross over (figure 18). The direction of the oil flow is reversed, turning the drum in an anti-clockwise direction (lowering the bucket).

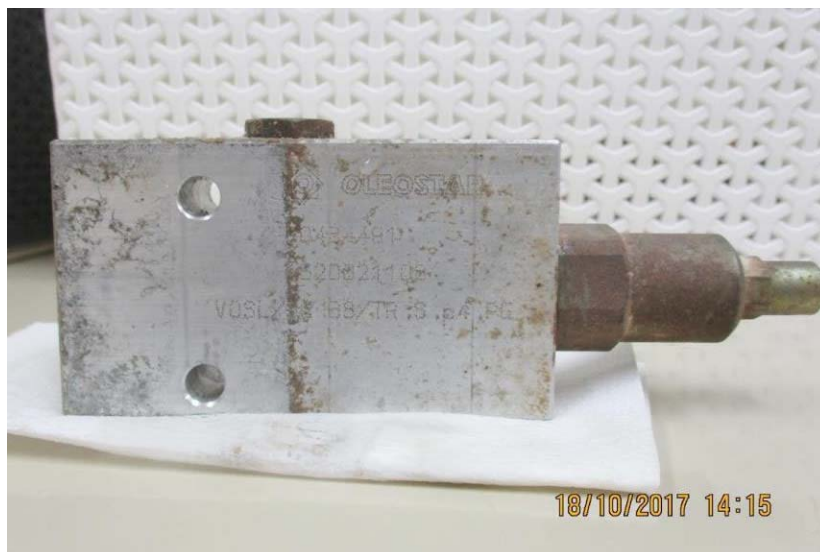
Figure 19: The counter balance valve sized from the hoist.

The valve on the Ag-Fab hoist's hydraulic system is a Walvoil 4 port- single acting counter balance valve (Single acting – allowing flow in one direction only with a spring-loaded return actuator), part No. VOS/SC 38/TR.S.p4.PG (figures 18 and 19). An example of the counter balance valve in its rest position, that is when the hoist is not in operation, is shown in figure 20.

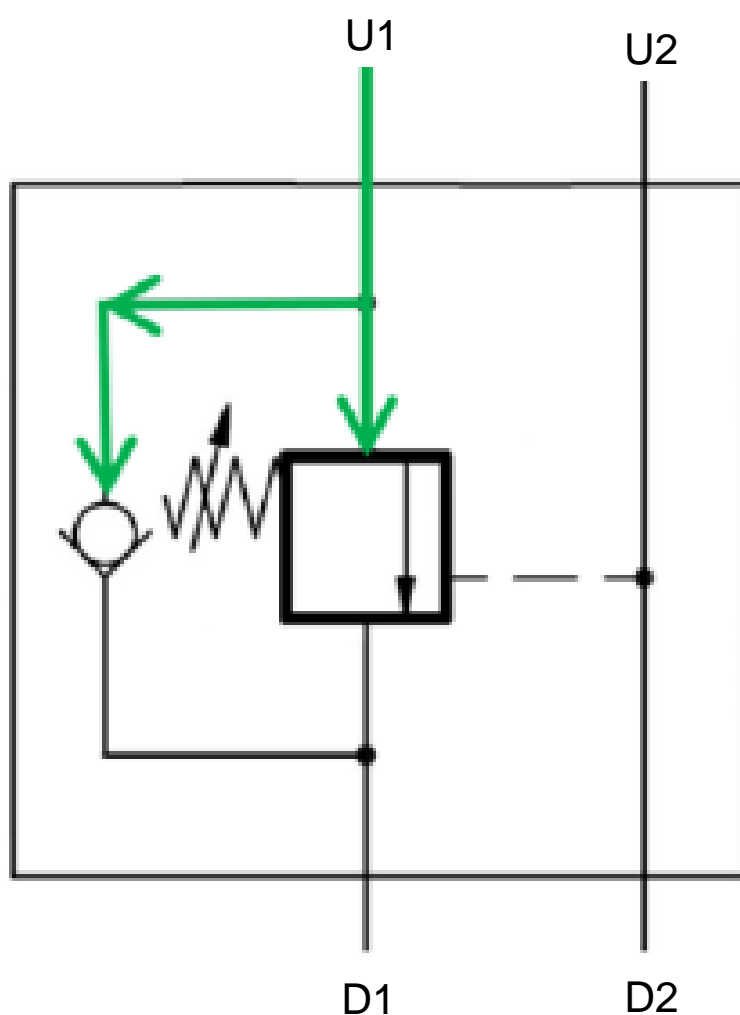
When the bucket is being operated in the lowering sequence, oil will flow through the counter balance valve in reverse, flowing through ports D2 and U2 and returning via ports U1 and D1. Reverse flow is generally prohibited due to a ball valve (figure 22). To achieve reverse flow a pilot signal, activated by the pressurised oil (figure 23 red lines), aligns the port to allow oil to return to the tank (figure 23). The operation of this valve was described as:

Figure 22: Flow of oil prevented due to the ball valve.

The weight of the bucket then turns the motors (freewheeling) and because of the counter balance valve being single-acting (figure 18 and 22) there is no resistance to the motors pumping oil forward (figure 26) resulting in the motors turning and the bucket free-falling down the shaft.
