HIGH POTENTIAL NEAR MISS FALLING OBJECT

SR-75 CONCRETE SWIVEL STEADY BAR RETAINING BOLTS

EXECUTIVE SUMMARY

Date: 27th January 2021

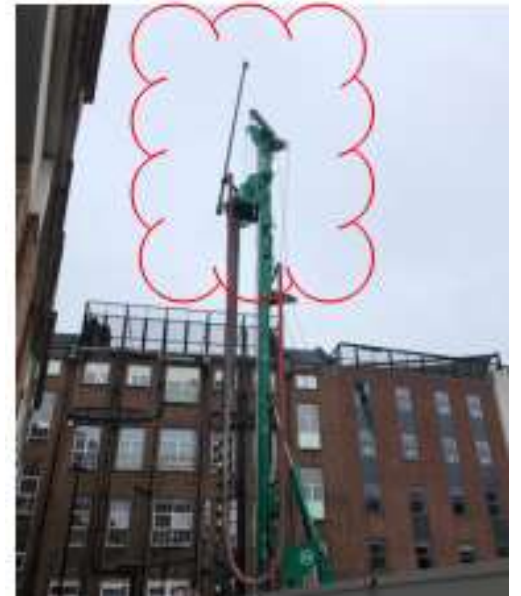
Piling rig: Soilmec SR75 in CFA ECT2 mode (manufactured Nov 2020)

Rig Fitted with 8mtr Kelly Pole Extension and Safety Locking Indicator light system (Green when locked/Yellow when Un locked)

The piling rig was installing 750mm secant wall piles to approximately 21m whilst working in close proximity to the site boundary. An exclusion zone was in place outside of the site and managed by the Principal Contractor.
