Guidance Note QGN 29

Surface tailing storage facility management

Mining and Quarrying Safety and Health Act 1999

December 2017

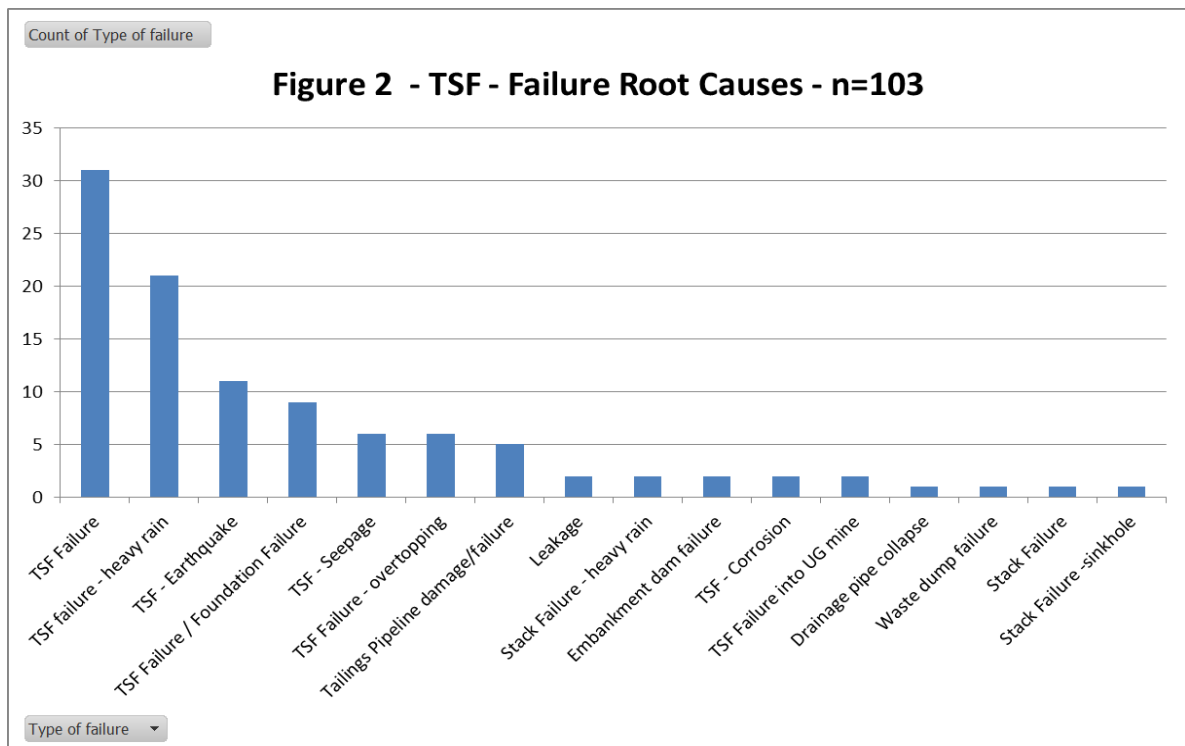
Figure 2 below provides a frequency analysis of historical TSF failures and their root causes¹.
