INVESTIGATION INFORMATION RELEASE

Worker's foot trapped in scraper conveyor

Event: Serious injury in underground coal mine

Location: Appin North Mine, Appin Colliery, Appin NSW

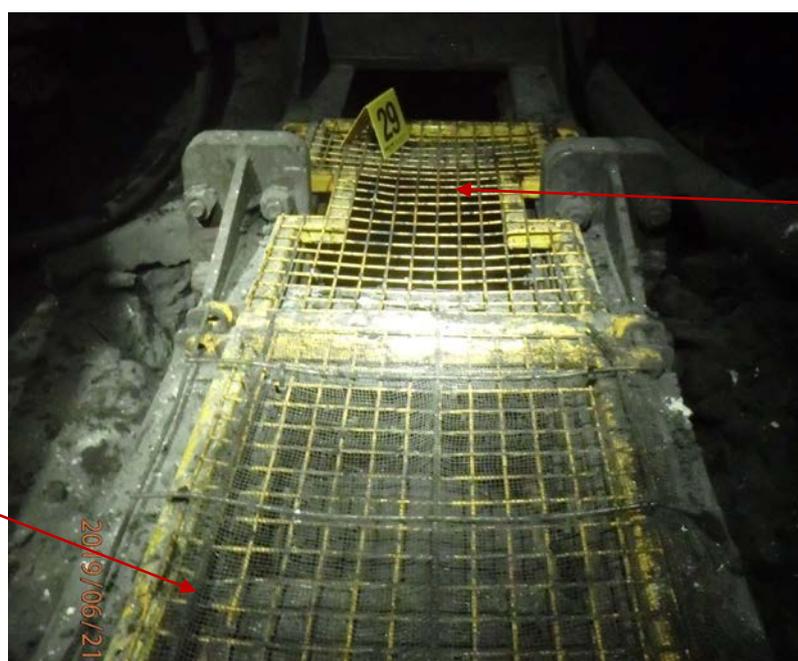
Figure 1 Scraper conveyor showing the lack of guarding and the position where the worker's foot was trapped

Reinforcement mesh overlaid by tech mesh on top of a fixed guard.

Foot entered conveyor and was trapped.

A labour-hire worker was undertaking tasks near a newly installed scraper conveyor. The worker was walking on the scraper conveyor while it was operating, when his foot fell through a section covered only by 150 x 150 millimetres reinforcement mesh overlaid by tech mesh (fine steel screen mesh) (see figure 1). This section of conveyor did not have appropriate fixed guarding.

The worker's foot contacted a flight bar and became trapped in the conveyor. The worker had to forcefully pull his foot out of the conveyor. The worker suffered serious injuries to his foot that will require ongoing surgery and rehabilitation.

Unsafe plant and equipment can cause serious injury and death. Appropriate guarding and barriers must be in place to prevent access to, and contact with, moving parts of plant.

Guards must be suitable and installed correctly in areas where workers may require access and stand on the guards. If the guards are not intended to be used as access or stood upon, additional measures must be in place to control incorrect use by workers.
