INCIDENT ALERT

LOCATION:	AGGREGATE DREDGER	ALERT STATUS:	Normal
ACTIVITY:	MAINTENANCE & HOUSEKEEPING	DATE ISSUED:	01/02/2016 12:49:05
SUB ACTIVITY:	N/A	INCIDENT No:	01425

Isolation lock out equipment near miss

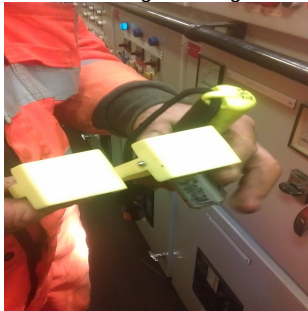
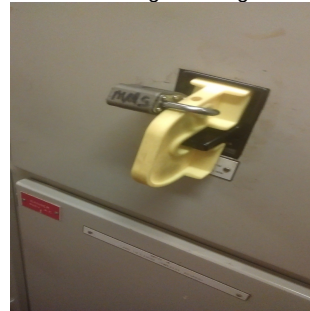
The equipment being isolated is switched on/off using a Bakelite switch, and the lockout equipment fits over the switch when it's in the off position. The equipment is fastened to the switch by a screw which grips switch and prevents the lockout from being removed. To prevent the screw being unscrewed a padlock is fitted which shields the screw head from a screw driver.

The lockout was fitted following procedure, however on inspection when the lockout equipment was touched and moved it slid off the switch completely.

On investigation it transpires that because the switch is made of Bakelite which is hard and also brittle, it is not possible to screw the screw down on to the switch with sufficient purchase to gain enough grip to secure the lockout equipment in place.

A solution to this problem is currently under investigation.

Highlights the importance of testing and checking all aspects of the lock out process.

Highlights example of an unexpected problem when new elements introduced to lock out procedure.
