Loader reversed over light vehicle

Mines safety alert no. 342 | 05 June 2017 | Version 1

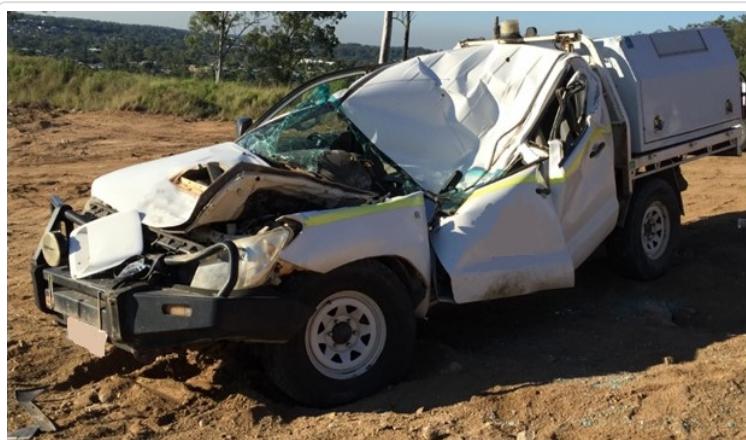
A loader was distributing stemming on a shot. A driller's assistant was giving directions to the loader operator using hand signals. After dropping the last of the stemming onto the shot, the loader operator reversed uphill off the shot to exit the area. While doing so, the rear of the loader collided with a dual cab utility parked nearby, crushing the bonnet and cabin. There were no occupants in the vehicle at the time.

Ensure you have effective controls in place to manage the risks associated with vehicle interactions (vehicle to vehicle, vehicle to infrastructure and vehicle to people) at your site. This should include:

- Identifying what vehicle interactions take place at your operation.
- Reviewing the recommendations from previous safety publications associated with vehicle interactions.
- Applying the hierarchy of control when reviewing or establishing hazard and risk controls.
- Verifying that the controls are implemented and effective.
- Ensuring that personnel required to work near vehicles have effective methods of communicating in place.

Additionally, where personnel are required to enter an area while a vehicle is operating, the vehicle should be parked until the person leaves the area.
