## **NZ Safety Alert**

## Roof blown off in wind event

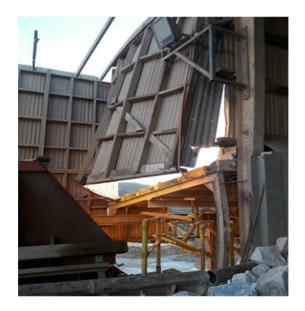
During a significant wind event, the roof of a material storage bin was blown off. It travelled approximately 60 meters over another shed, hitting power lines and landing on the opposite side of the State Highway. Power was cut to the site and remarkably no-one was injured.

During the same event the front wall of the shed was blown apart and the roof above the crusher, and reclaim tunnel, sustained minor damage.

- You have a system to ensure that all buildings and enclosures, including temporary and semipermanent relocatable structures, are adequately designed, sited, constructed and anchored.
- An adequate emergency response and rescue system is in place in case a severe weather event causes injury, entrapment or damage to buildings or infrastructure.
- Everyone on site, including contractors, are made aware of the site's emergency response plan (including location of safe places) and what is expected of them.
- Your site has a process for identifying and warning anyone who could be affected by severe
  weather events and a system for moving people to a place of safety including considerations for
  the evacuation of people from site.
- Regular workplace inspections are conducted to identify plant and structures that may be susceptible to damage from severe weather events.
