Safety Alert

Arc flash incident

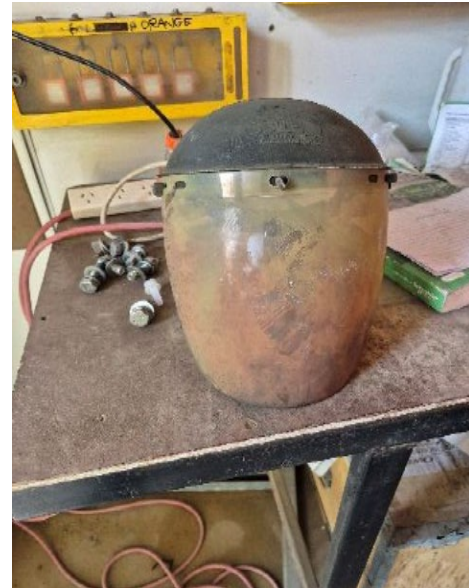
Following a fire suppression system discharge, all associated switches were isolated to allow electricians to test each isolation individually.

During this time, a large rock became jammed in the jaw crusher, requiring the use of the rock breaker. As the Motor Control Centre (MCC) switches remained isolated, the rock breaker needed to be re-energised. During the attempt to restore power and restart the rock breaker, an arc flash event occurred.

The energy released could have resulted in serious, life-changing injuries, however, processes and procedures were followed, and there were no serious injuries.

1. Critical controls relied on for arc flash incidents are identified and managed.
2. Where practical, use energy reducing switches in MCCs to reduce the energy potential in switchboards.
3. When conducting electrical work, all workers wear arc-rated Personal Protective Equipment.
