# Safety Alert

25 October 2024

## Company convicted over conveyor fatality

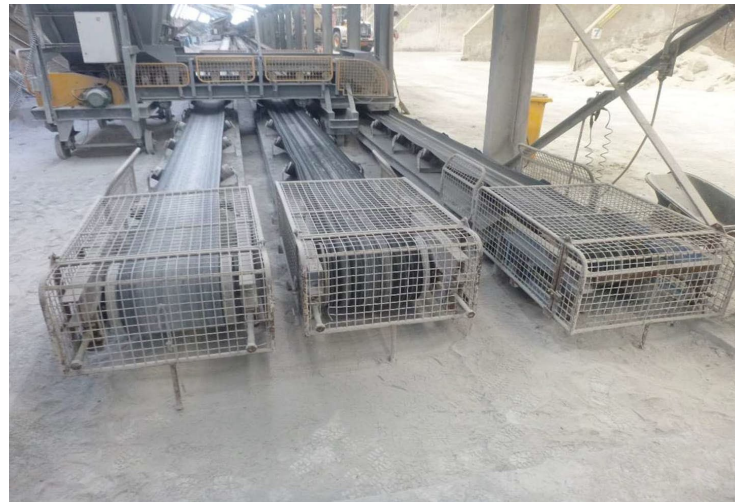
The victim lost his footing whilst trying to step over the running belt and fell. He rolled several times and was dragged underneath the metal frame of a crossing conveyor belt.

1. Emergency stop lanyards are installed along all conveyors where there is a risk of someone falling onto the belt.
2. All nip points are guarded, and engineered controls are in place to keep workers away from entanglement hazards.
3. Emergency stops are appropriately located and regularly checked to ensure they are working.
4. No maintenance is conducted on plant while it is running without adequate guarding in place.
