# Safety Alert

## Damage to dump truck lockout assembly

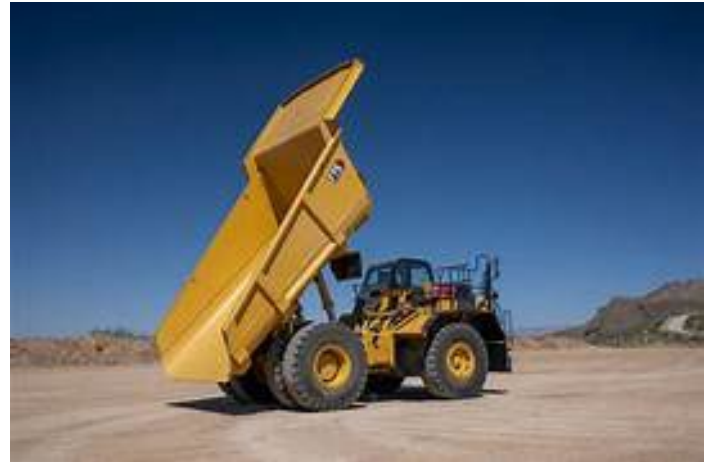
Lock out pins were used to secure the raised dumper tray. Once completed, contractors left the site with lockout pins still in place.

The dump truck was required, so the lockout pins were removed and placed into the wrong holding location. When the hoist was raised to tip off a load, the lockout assembly was damaged.

1. All workers are trained and competent in lock out systems and procedures, including those covering locking systems on mobile plant.
2. Contractor management procedures include verification of lockout and verification that locks have been removed once maintenance work is completed.
3. Contractors are adequately supervised, particularly when conducting maintenance tasks.
