# Safety Alert

## Fire in loader engine bay

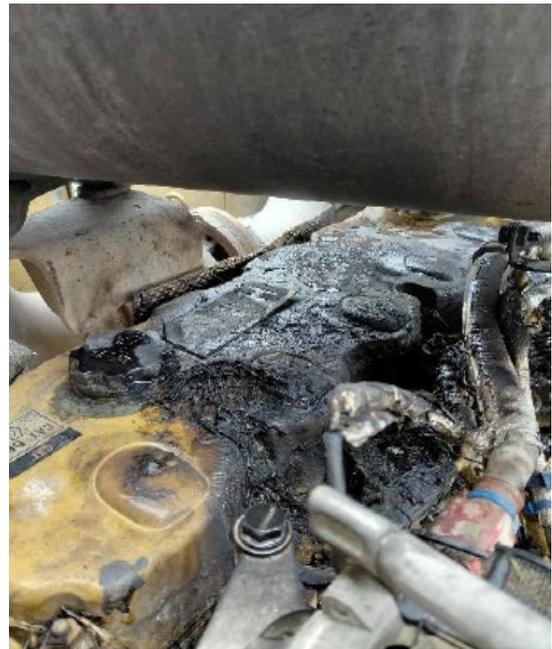
A loader operator on a Cat 972 Wheel Loader noticed the smell of smoke in the cab. As this worsened, the operator drove to the workshop where a hose was used to douse a small smouldering bird's nest in the engine bay.

There was heat damage to several sections of wiring and sensors in the engine bay, as well as the rocker cover and alternator.

1. Pre-start checks are completed on all mobile plant, including opening the engine bay completely to check for any signs of birds' nests.
2. When returning from a break, check for any bird activity near your machine, as some birds can build a nest in 45 min.
3. You check behind guards, in air filter ducts etc. for signs of bird activity as birds prefer warm, sheltered spots.
