Safety Alert

Worker injured exiting truck

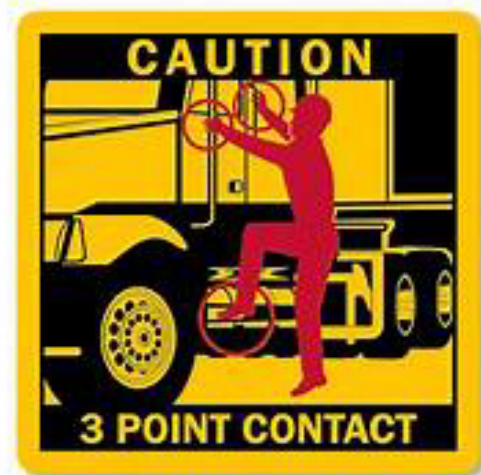
A worker was dismounting a dump truck to get into the excavator when a rock under his right foot moved, causing him to roll his ankle.

The incident highlights risks associated with unstable ground during routine plant access, compounded by role overlap that introduced non-routine hazards.

Normalisation of uneven footing reduced risk awareness, and continued work after injury suggests the need for clearer expectations around injury response and stopping work.

1. Workers always maintain three points of contact when climbing up and down a ladder.
2. There is a good solid base that is clear of loose rocks under all ladders when exiting the vehicle.
3. Where fitted, ladder extenders are used to reduce the distance to the ground from the bottom step.
