Resources Safety and Health Newsflash

Fire Suppression System Failure to Activate

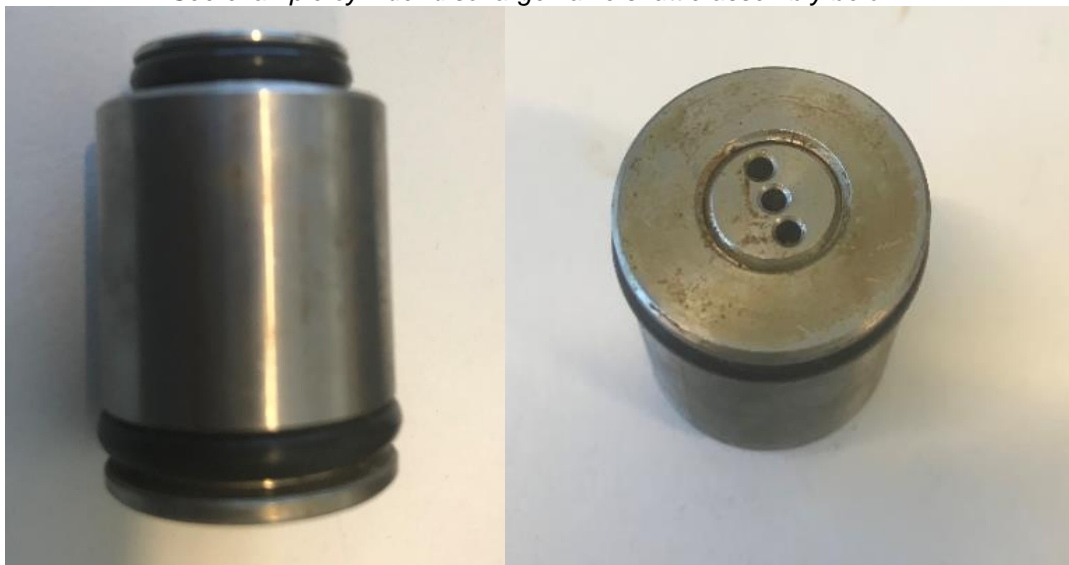
Upon manual activation of an fire suppression system during routine servicing at an open cut coal mine, the system failed to actuate as per design. Upon further investigation it was found that the dimensions of the “cylinder discharge valve shuttle assembly” were outside of tolerances causing it to not seat or actuate correctly. The Department have been made aware that this fault has been identified on several machines.

See example cylinder discharge valve shuttle assembly below

All mines should immediately audit all machine mounted fire suppression systems to determine that the system is functional. Mines should ensure that the “cylinder discharge valve shuttle assembly” is dimensionally correct and functioning correctly.

- **Confirm that suitable inspections are in place.**
- **Confirm that the inspections are relevant and applicable to the potential failure modes.**
- **Consult with the OEM or service provider to ensure that the correct “cylinder discharge valve shuttle Assembly” is installed.**
- **Confirm with the OEM or service provider to ensure all current stock holdings of “cylinder discharge valve shuttle assemblies are correct.”**
