# NZ Safety Alert

13 May 2022

## Another ADT rollover

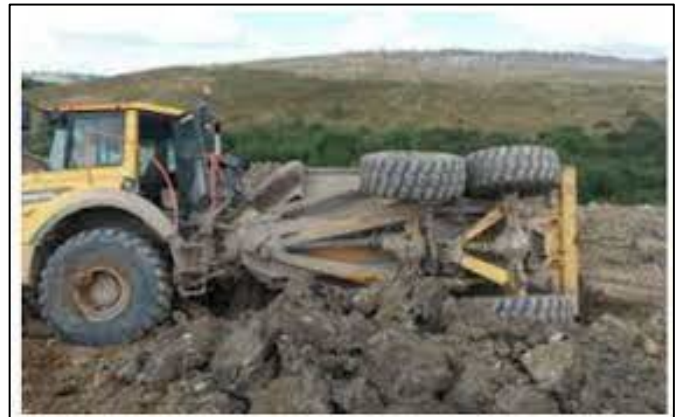
While carting dirt at the quarry, the operator of a loaded articulated dump truck felt something give way while negotiating a small left-hand bend, causing the truck to mount the left-hand road bunding and tip its bin to the right, onto the haul road. The cab of the truck stayed upright, and the driver was uninjured.

An investigation found that the left-hand tyre under the truck bin had rolled off the rim. No punctures were found, however the other tyres on the vehicle were under inflated by 10-15psi from normal running pressure.

1. Prestart checks on mobile equipment include visual tyre condition checks.
2. All mobile plant is maintained in accordance with Original Equipment Manufacturers (OEM) recommendations.
3. Haul roads and edge protection are well maintained to avoid potholes and uneven surfaces.
