# Uncontrolled Release of Energy - Polyethylene Pipe

Explosives safety alert no. 374 | 28 May 2020 | Version 1

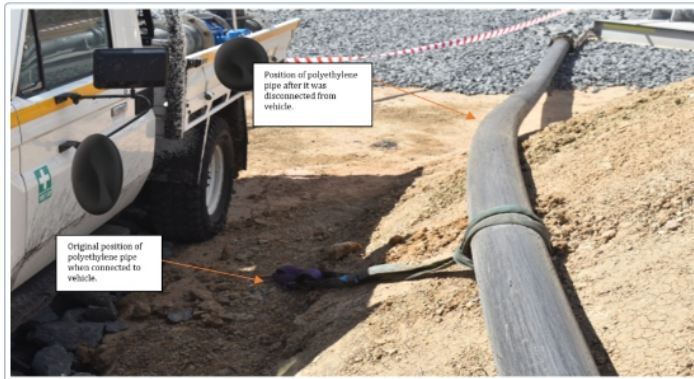
It is common practice to relocate lengths of polyethylene pipe by towing it with mobile plant such as light vehicles or small excavators. While undertaking these activities the pipe has become bowed for various reasons then suddenly released, springing back striking the CMW who was positioned in the line of fire. CMWs have also been injured when disconnecting piping from the towing vehicle and pumps. In these cases the stored energy source had not been identified.

Example of a sudden release of stored energy

- Mines must ensure there is a documented procedure for towing poly pipe.
- Mines must ensure a risk assessment is conducted when there is a variation required to a documented procedure.
- Mines must ensure plant and equipment used is fit for purpose.
- Mines must ensure pump crew personnel have completed RIIWMG201A - Conduct dewatering activities in surface operations or equivalent.
