# SAFETY ALERT

<b>INCIDENT</b>	Near Miss Plant v Person
<b>SUBJECT</b>	Surveyor Walking through earthworks site
<b>INCIDENT DATE</b>	28-02-2020
<b>BUSINESS UNIT</b>	Peka Peka to Otaki

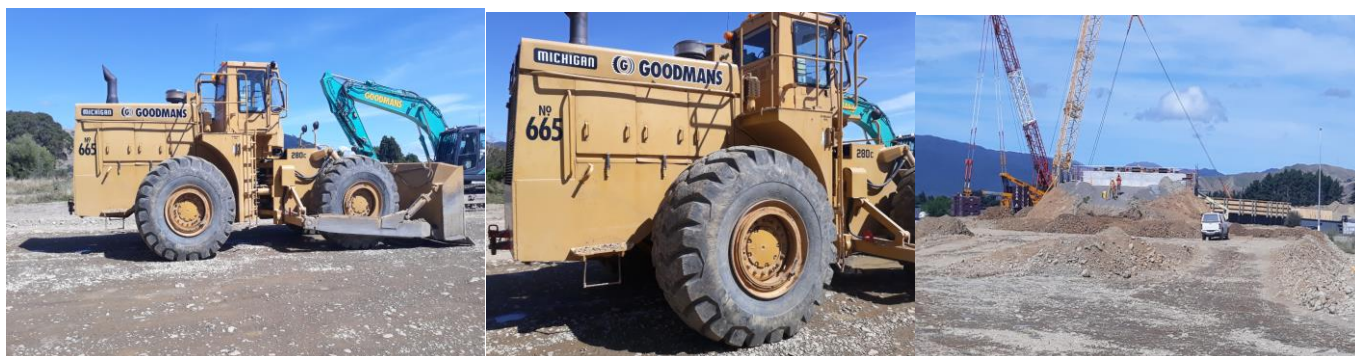
He has approached the moving Michigan dozer from the right side, as the dozer has pushed a load forward the machine has stopped, he saw the driver look over her right shoulder and assumed that she had seen him. He has then started to walk across the rear of the dozer.

The dozer driver had not seen him nor acknowledged his presence and reversed missing the surveyor by 1m.

- All work stopped in the vicinity.
- Immediate site review with FCC site supervisor, Contractors supervisor and Foreman.
- Upon review mandatory no staff on site on foot unless all work stopped in future.
- During stop work survey task completed.

- Total ban on staff on foot in high traffic areas without prior approval and total machinery shut down.
- Review of haul road traffic procedures covering working on foot in that area.
- Review of communication system in the Michigan dozer.
- Site wide Vehicle management plans to be drawn up at pre-starts and placed in dog boxes.
