Waste Infra Network Services

Health, Safety, Environmental and Quality Moment

Issue Date: 30/09/2021 Ref number: CSP010

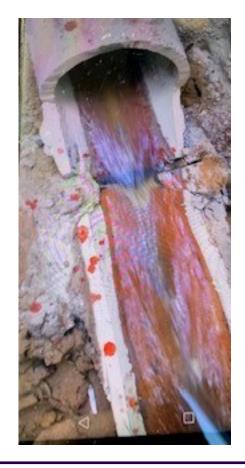
A civils operative was using an angle grinder to cut a section of clay pipe within an excavation to repair the sewer.

When doing so the grinder kicked back and travelled across his right forearm narrowly missing major veins and tendons.

The preliminary investigation has identified that the operative was forcing the grinder to cut rather than allowing the tool to do the work.

Section of pipe being cut with grinder

- Ensure that you are using the right tool for the job
- Ensure that you have the right training to use the tools, and that you are competent to use them
- Check blades and discs prior to use and ensure they are not blunt or excessively worn
- Do not force the tool. Allow the tool to do the work for you, if you have to force it then it is not the right tool for the job. Stop and seek advice from supervisor/ manager
- Wear the correct level of PPE for the tool you are using if unsure check your documents in Modular Plus or call your supervisor

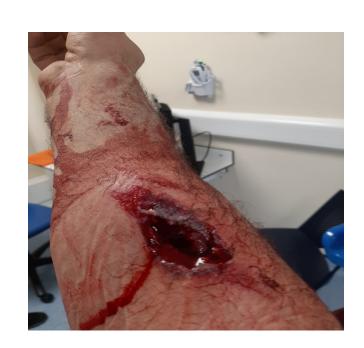
The injury has resulted in surgery to repair a smaller vein, stitches and lost time from work.

Injury site requiring surgery
