NZ Safety Alert

6 March 2020

Injury stepping off loader

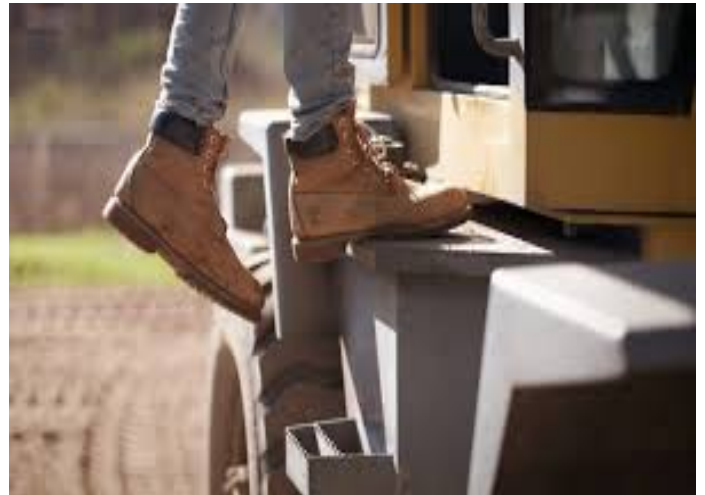
After checking and replenishing oil into a 950H CAT front-end loader, a worker attempted to step off the loader back onto firm ground when he heard a snapping noise and felt sharp pain in his lower right calf muscle.

The incident happened not long after the workers first break around 12pm. The weather was fine and not frosty, and it was not the first time this employee had climbed on and off the loader.

The injury was first diagnosed as a sprain but did not improve after resting, so was re-diagnosed as a torn calf muscle. The worker was given further time off which eventuated in a total of 7 weeks. He has since returned to work.

1. Access and egress on mobile plant is fit-for-purpose to ensure workers are not injured climbing onto and off machines.
2. Workers report injuries including minor strains to ensure they are fit for work on that day and subsequent days.
3. Workplace observations are conducted to identify activities that could result in occupational injuries.
4. Medicals are conducted to ensure workers are fit for the tasks they conduct.
