# NZ Safety Alert

9 October 2020

## Bar hits worker in face

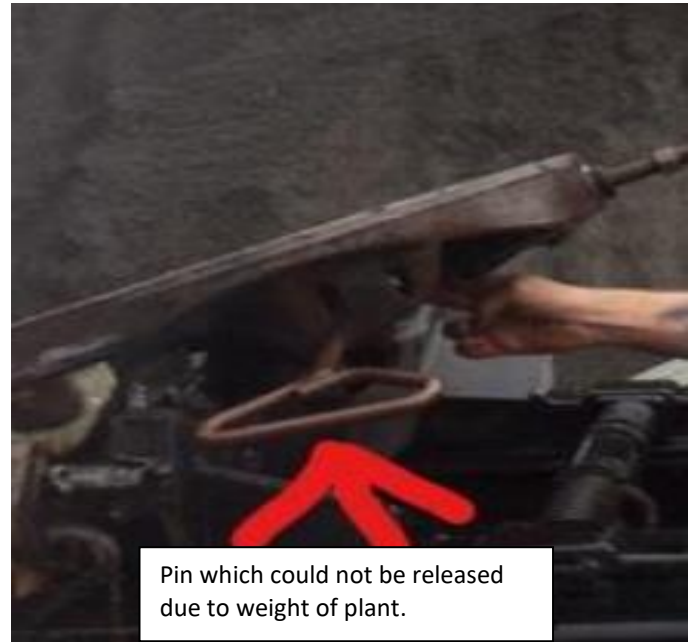
During assembly of a new screen on the crushing plant, a crane lifted the plant to allow the wheel assembly to be released. While a worker was attempting to remove the pin of the wheel assembly, the wheel assembly became jammed.

The worker used a bar to try and release the pin and while pulling on the bar, it slipped out and struck the worker in the face, chipping a tooth.

The team working on the plant shift were experienced at working together. While there was no supervisor present, the task was discussed verbally – however no risk assessment was completed, the possibility of this situation was not discussed, nor did they discuss it before manually trying to release the pin.

1. Effective risk assessments are conducted prior to commencing any non-routine task.
2. Workers stop and reassess the task when something changes, or the task cannot be completed as originally envisaged.
3. Workers are trained and regularly assessed competent in conducting effective risk assessments including stopping to re-group and discuss a new task step that may arise during an activity.
