NZ Safety Alert

Faulty tow ball and coupling cause death

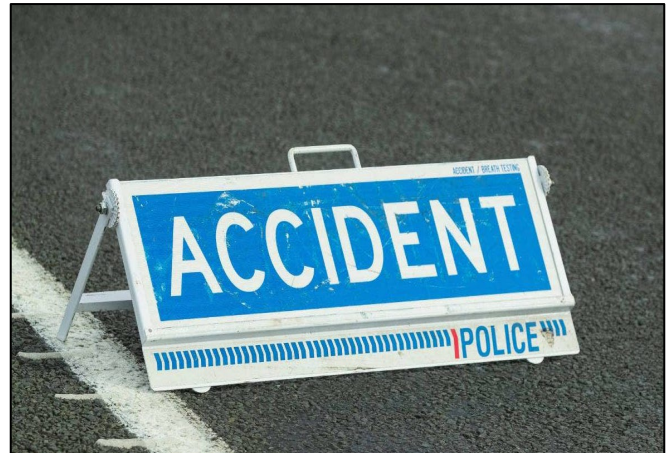
A Northland trucking firm were recently sentenced for causing the death of a 9-year-old girl after a badly worn-down tow ball and coupling on a trailer caused the trailer to dislodge.

The trailer's safety chain failed, disconnecting it from the truck towing it. The trailer collided with an oncoming car the young girl was travelling in, near Mata, south of Whangārei.

On top of that, the trailer's certificate of fitness had expired, and its tyres had uneven pressure.

1. Regular inspections of all vehicles are conducted including trailer couplings and tow balls to ensure they are safe and roadworthy.
2. Prestart checks on trucks and trailers include tyres, tow balls and couplings.
3. You identify and log the maximum weight every towing vehicle and trailer can manage, to ensure that towing componentry is rated safe for use.
