# SAFETY BULLETIN

## Configuration of work baskets

This safety bulletin provides safety advice for the NSW mining industry.

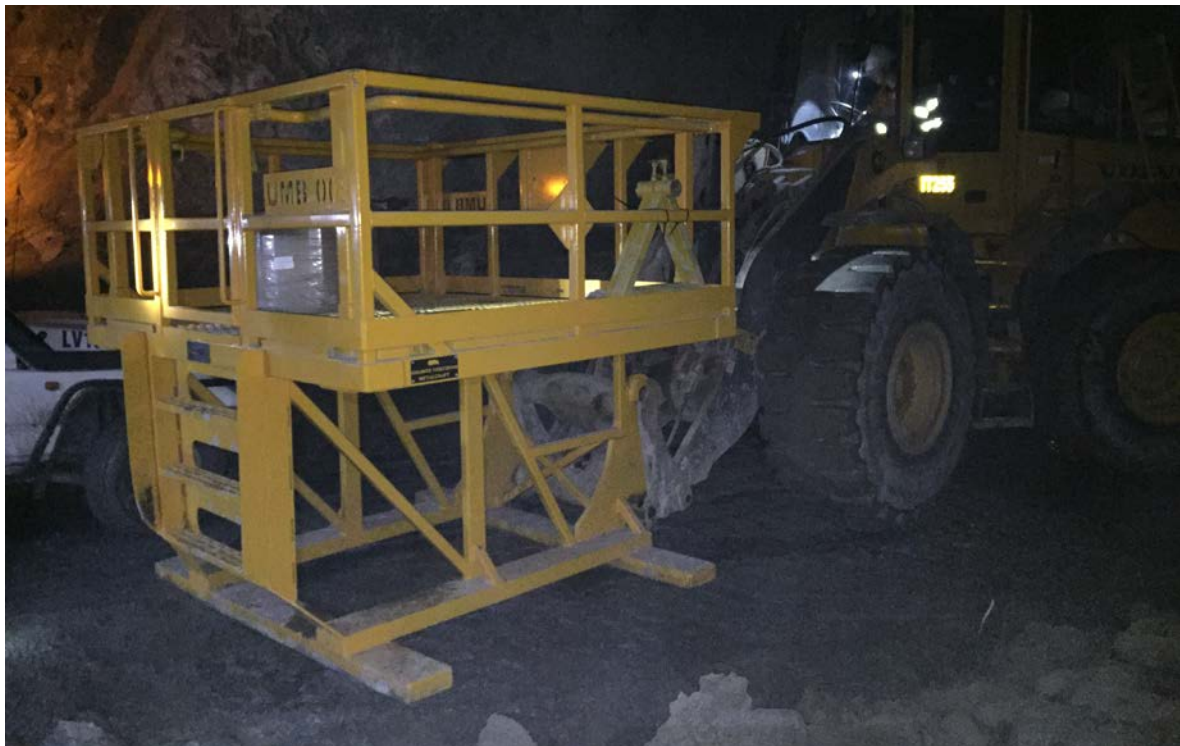
Work baskets attached to integrated toolcarriers (ITs) are widely used in metalliferous mines. There are various designs used, with some having internal grab rails on one or more sides. Crush protection posts are not routinely used due to the risk of being caught up with or damaging electric cables or other services. Work baskets are often moved at low speed while attached to the IT with workers in the basket to facilitate tasks including running out and working on services, or to charge different areas of a face or blastholes.

*Figure 1 A work basket attached to an integrated toolcarrier*

There has been a recent increase in the amount of crush injuries occurring between the edge of work baskets and services, roof or walls. All of these incidents have been associated with workers placing themselves or body parts into potential pinch point areas while the work basket is moving.

Work baskets are usually entirely painted yellow which fails to assist workers in identifying potential pinch points.

- Operational risk assessments must be completed for all work baskets. The risk assessment must consider:
  - crush zones and how they are identified
  - how crush zones are highlighted including by painting them in a stand-out colour such as red or applying red/white striped reflective tape
  - standardising the design of work baskets
  - designated safe places for handholds and worker position when work baskets are being manoeuvred.
- Training should clearly state where workers should stand when a work basket is being manoeuvred taking into account the visibility of workers in the work basket by the machine operator.
