NZ Safety Alert

Operator struck by compressed air hose

8 June 2018

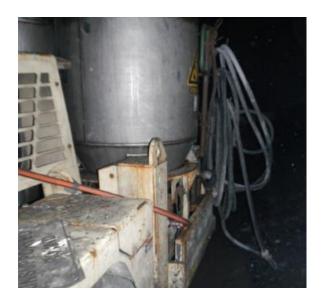
A blast crew was setting up the charge-up vehicle in preparation for charging blast holes. A worker removed one end of the 1-inch air hose from the rear of the vehicle and connected it to the compressed air line dropper. Without checking the other end of the hose was connected, he turned the air line fully on, allowing maximum pressure through the 1-inch line. The air line was not connected to the machine and the hose rapidly sprung back, knocking the worker to the ground and dislodging his hard hat. Another worker heard the noise and came to the aid of the injured worker.

We recommend that all sites review tasks that involve the use of high pressure air, water and/or hydraulic fluid. You need to ensure that:

- Where appropriate, safety devices such as whip checks, air shut off valves, taps and solid fittings etc. are installed.
- Procedures for turning on, and turning off, high pressure lines are reviewed, particularly
 around ensuring both ends are connected prior to pressurising the line, and that both
 ends of hoses are together when not in use.
- Workers are trained and assessed as competent to work with high pressure equipment.
- Activities are adequately supervised, and tasks observed, to ensure risk controls are in place and are effective.
