Excavator brings down powerlines

29 March 2018

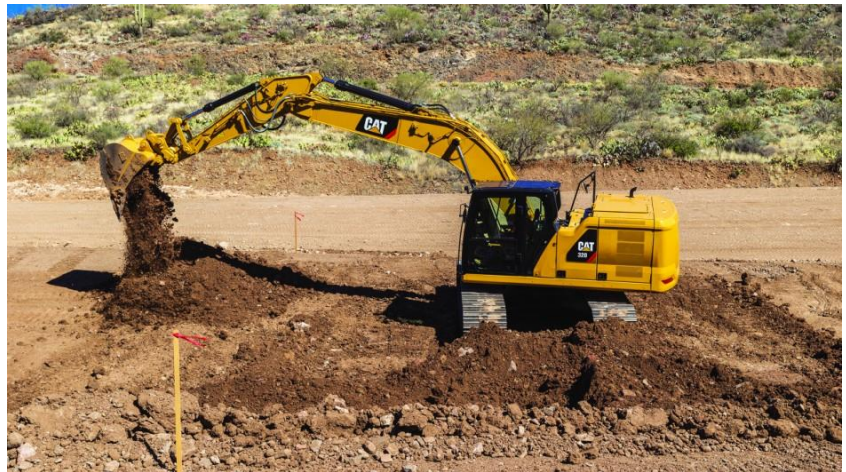
An excavator was working approx. 50 m from powerlines loading out from a stockpile. While tracking under the 11kv powerline to another stockpile, the boom contacted the overhead powerlines. This knocked out power to the plant and local community. The excavator operator was not aware of the contact until advised by the dumper operator.

Pressure release, including electrical events, are a major cause of serious harm and fatalities in the extractives sector. This incident highlights the need to be vigilant when working around live powerlines. We recommend that all sites review procedures, and practices, to ensure that:

- **Powerlines are underground or, if overhead, are clear of any stockpiles or mobile plant work areas.**
- **All overhead powerlines on site are clearly identified and signposted, including the height and power supply (e.g. 11kv).**
- **If possible, isolation procedures include the isolation of power when mobile plant is working around powerlines.**
- **Procedures for working under or near overhead powerlines include suitable separation distances between mobile plant and the powerlines and barriers between the powerlines and workers.**
- **Workers are trained in, and regularly reminded of, the potential hazards associated with overhead powerlines.**
- **Regular workplace inspections are conducted to ensure compliance with the procedures listed above.**
