NZ Safety Alert

Failure to follow procedure puts workers at risk

26 January 2018

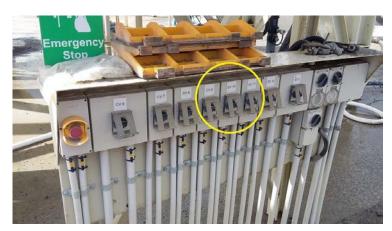
On Monday, the plant operator did not complete plant prestart checks, despite completing the pre-start check sheet. When he attempted to start the plant, he received error messages but overrode these and ran the main belt.

When he noticed no material on the belt he investigated to find that the locked-out conveyors had not started, and a considerable amount of material had built up at the transfer point between the feed belt and the isolated conveyors.

Entanglement, including people getting caught in conveyors, is one of the four fatal hazards that results in 80% of fatalities in the extractives sector, both in New Zealand and internationally. The plant operator's actions could have resulted in serious injury or death. We recommend that all sites review fixed plant pre-start procedures to ensure that:

- No plant is started after maintenance until pre-start checks have been conducted to ensure that all guards have been replaced, locks are removed, isolation switches reset and that the plant is safe to operate.
- Risk assessments are completed on all non-routine tasks to ensure that hazards are identified, risks assessed, and effective controls are put in place.
- Regular workplace inspections are conducted to ensure that risk controls are in place and are effective.
- All workers are trained, and regularly re-trained, in isolation and lock-out procedures.
