NZ Safety Alert

June 2019

Flyrock damages utility

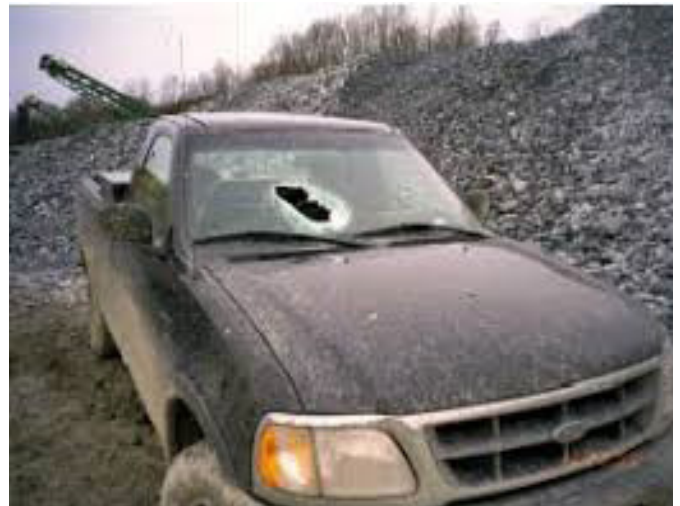
During a blast, flyrock went through the canopy window on a utility.

1. Blast exclusion zones are calculated for each shot taking into consideration minimum safe distances for plant and people and based on actual burdens.
2. Consideration is given to laser profiling of faces and bore tracking of the front row of holes, in order to establish accuracy of drilling and actual burdens prior to loading a shot.
3. You have sufficient knowledge of your site's geology to help inform blast design and calculation of relevant safe exclusion zones.
4. The Blast Plan, including exclusion zones, is communicated to all on site on the day of the blast.
