MinEx Health and Safety in NZ extractives

NZ Safety Alert

March 2019

Loss of control of dump truck

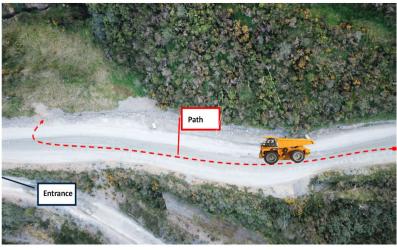
A watercart was being used to water a haul road to suppress dust in a quarry. Directly after the haul road was watered, a dump truck was descending the road empty when the dual wheels locked up and the operator lost control of the dump truck. The operator was able to steer it towards the inside batter rather than the edge of the road and no injury or major damage was sustained. A dump truck in front of this one, experienced partial loss of control and warned the driver just prior to him losing control.

- 1. Care is taken to ensure haul roads are not overwatered.
- 2. Regular inspections of haul roads are conducted to ensure they are not too slippery after watering or heavy rain.
- Operators are trained and assessed as competent to operate mobile equipment. This needs to include model/equipment specific training and assessment.
- 4. Lessons from incidents, including learnings are shared with all workers.
