## Fire in ammonium nitrate store

Explosives safety alert no. 97 | 26 February 2018 | Version 1

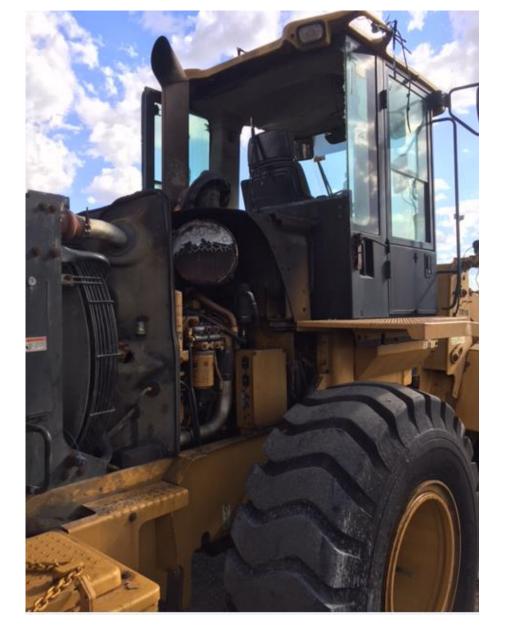
A front end loader caught fire inside an ammonium nitrate store whilst loading into a hopper. The loader suffered an ignition circuit failure causing the wiring to ignite, engulfing the engine bay. Efforts to extinguish the fire were hampered due to the engine cover. The loader was removed from the store area and was extinguished by flooding with water.

Review ammonium nitrate handling activities involving machine loading operations, to identify and control all

· hazards and risks associated with the task.

Inspect to certify that all vehicles and machinery powered by internal combustion engines and operated within the store meet the requirements of section 9.3.3 of Australian Standard 4326:2008 *The storage and handling of*

• oxidizing substances.
