# Mobile equipment operator injured when seat belt failed

Mines safety alert no. 341 | 11 April 2017 | Version 1

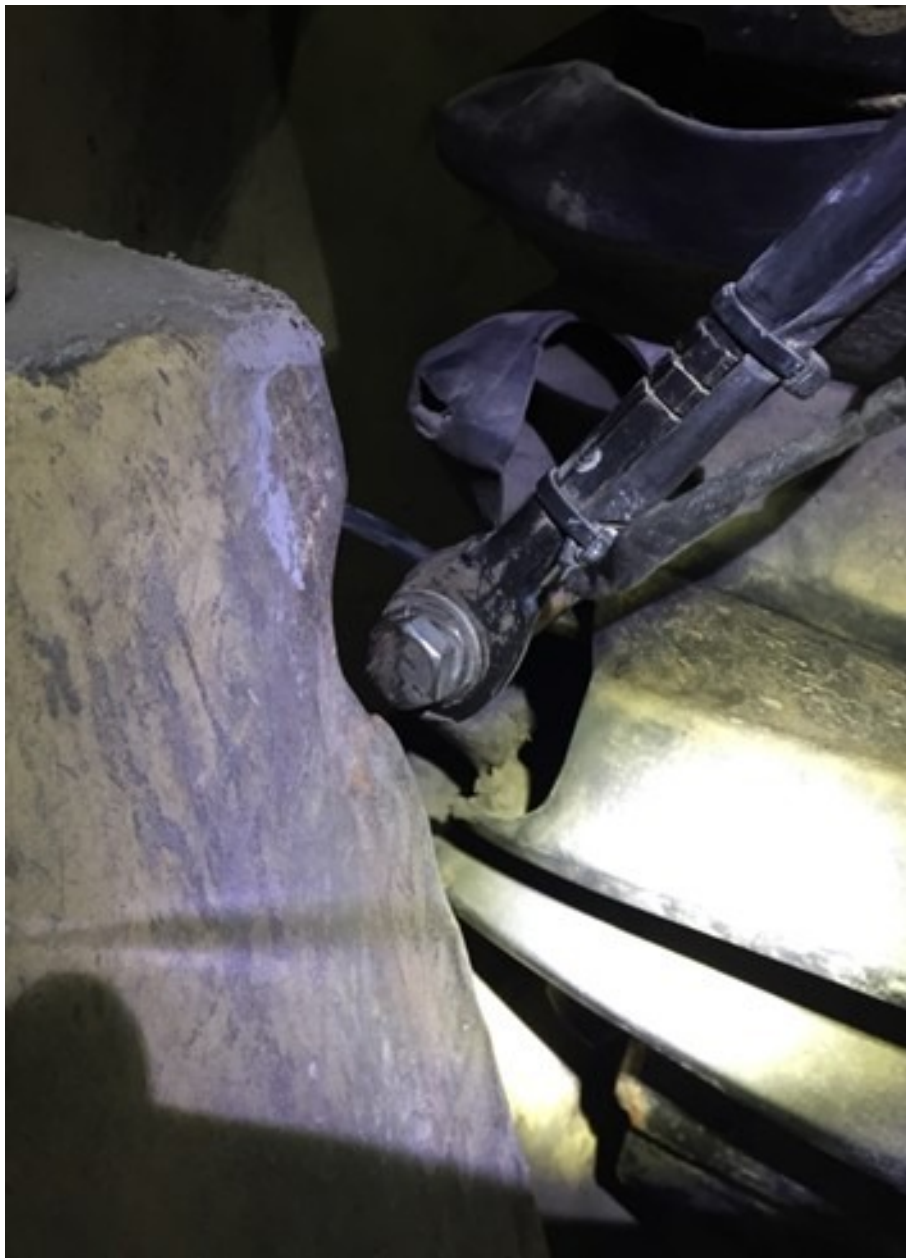
The operator's seat belt was found to be buckled together but one half of the seat belt had detached from its anchor point. The anchor point fixing bolt was found still in the seat belt stem eyelet.

The anchor point fixing bolt was found to have completely unscrewed from its mount on the side of a suspension seat frame. The bolt thread was in good condition, clean and was easily able to be screwed back into the mounting point. The bolt head showed signs of rubbing wear.

It was found that the rubbing marks on the bolt head corresponded with marks on the seat frame. The head of the bolt had been striking the panel for some time. The action of the seat suspension exacerbated this contact and over time had contributed the bolt to coming undone.

All sites should inspect their mobile equipment to ensure:

- all seats are fit for purpose and meet the OEM specifications
- all seat mounts and seat belt anchor points are checked for security
- all seat belt interlocks, if fitted, function as per the OEM specification
- OEM information pertaining to the correct adjustment of the driver's suspension seat should be made available to all equipment operators
- all seats, mounts and seat belts should be inspected, to verify there is no interference between them and any other items in the cabin that could prevent the safe operation and intended function of the driver's seat
- inspection of seat mounts, seat belt anchor points, seat belt interlocks, if fitted and seat belts are included as part of scheduled maintenance programs.
