NZ Safety Alert

ADT mechanical failure

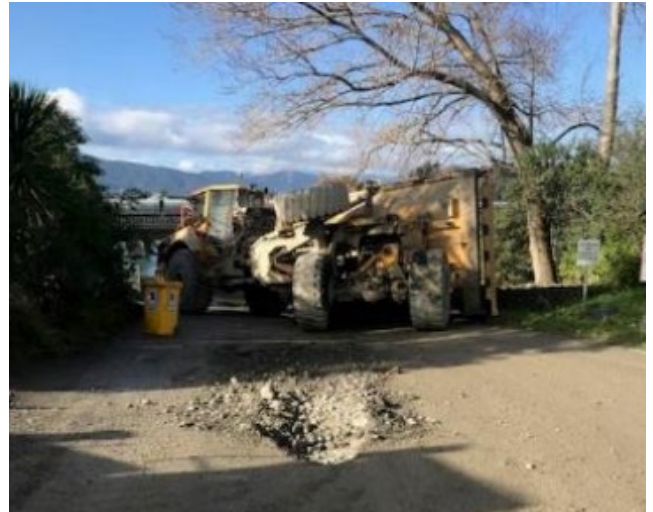
A dump truck operator was travelling towards the quarry and was slowing down to go under a bridge when it felt like the brakes had locked up and the whole tray was thrown up and onto its side. The operator called for help on the RT and the scene was isolated. The vehicle was locked out and all traffic was diverted away from the area.

An inspection of the ADT found a bolt had sheered causing the rear axle to come loose and dig into the haul road, flipping the tray onto its side.

1. All mobile plant is maintained in accordance with Original Equipment Manufacturers (OEM) recommendations.
2. Safety critical components on mobile plant are identified and changed out in accordance with OEM recommendations.
3. Haul roads are well maintained to avoid potholes and uneven surfaces.
