# NZ Safety Alert

## Uncontrolled movement of trailer

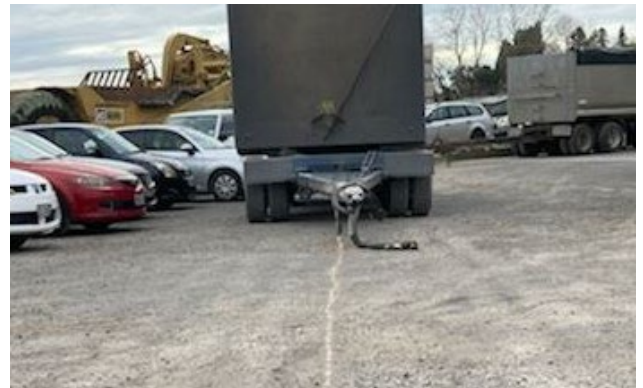
The driver disconnected the trailer, but the ring feeder pin was stuck, so he disconnected the trailer brakes. Once he got the pin out, he thought that he had engaged the trailer brakes.

As he moved the truck forward, the trailer started moving slowly towards the cars in the carpark. Another contractor on site, tried to slow down the trailer by hand, then saw the trailer brake button and engaged the brakes stopping the trailer.

1. All allocators and delivery drivers are aware of site restrictions and requirements at delivery sites.
2. Prestart inspections are conducted on all mobile equipment at the start of each shift, including truck and trailer connections.
3. All workers are trained and assessed as competent to operate mobile equipment, including braking systems, connecting and disconnecting trailers, and parking on inclines.
