# NZ Safety Alert

## Pressurised oil release on excavator

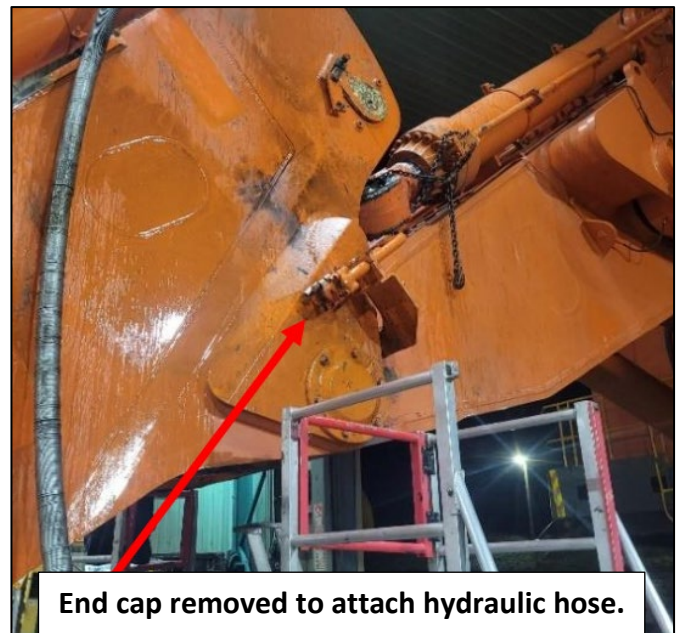
Fitters were undertaking a refit of an excavator stick to boom. As they removed the blanking caps from the stick cylinder pipe connections, pressurised oil escaped and sprayed approximately 5 metres across the maintenance bay and over a maintenance fitter who was working off a platform ladder (approx. 1.8m high).

The worker was using a platform ladder without the protection bar in place and could have fallen from height.

Prior to this, the system had been de-energised as per OEM procedure and workers were wearing task appropriate PPE and were not injured.

1. When working with systems that may have stored energy, that all pressure has been released prior to loosening fittings and plugs, in accordance with OEM requirements.
2. When using platform ladders with a safety bar, that the bar is in place before using the platform.
3. Regular workplace inspections are conducted to identify unsafe practices.
