# NZ Safety Alert

## Rock falls from excavator bucket

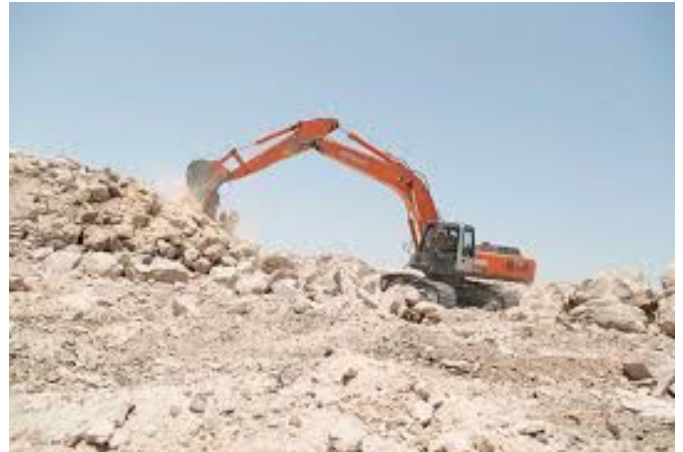
An excavator operator was moving rocks into a stockpile when a rock fell out of the bucket. The rock slid down the stockpile towards the digger. The operator proceeded to track backwards however the rock still hit the bottom of the left-hand corner of the cabin, bending bars and denting walkway on front of cab.

1. Fall hazards such as slope stability, loose material on batters, unstable or high stockpiles are identified in risk assessments.
2. Adequate and effective controls are in place to ensure no-one is exposed to the fall hazards identified.
3. Assess sizes, weight and shapes of rock correctly before attempting to lift with the excavator bucket onto stockpiles and ensure the excavator is at a safe distance.
4. Regular inspections are conducted of activities and areas where rock falls or other slope instability may occur.
