# Alert

## BBQ Gas Leak and Fire

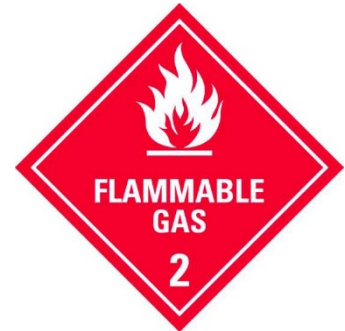
The subcontractor team was in its site container preparing for the day's work at Hawkins' Wynyard Quarter site. LPG gas from a BBQ, that had leaked into the container overnight, has ignited causing a fire. Initial indications are the ignition source may have come from a heat source such as an electric ignitor on the BBQ or cigarette lighter.

- An explosion or fire can be caused by the accumulation of gas in enclosed spaces when combined with oxygen and an ignition source. Ignition sources can include electrical sparks (including from light switches) and cigarettes, as well as open flames.
- Flammable products such as LPG and welding gases should be stored in well ventilated areas, preferably in the open or in dedicated storage areas. Conduct regular site inspections to confirm.
- The Project team had a designated smoking area and information around smoking Policy in their induction. It is important to regularly reinforce these requirements in toolbox talks and when monitoring the site.
- Any BBQs used on site must be used and stored according to manufacturer guidelines, and should be used in the site dedicated, outdoor location.
