# NZ Safety Alert

## Yet another ADT rollover

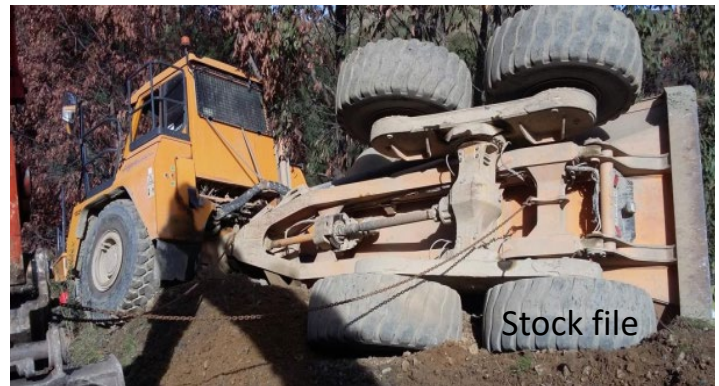
A contractor was operating an articulated dump truck on a quarry haul road. As he was coming around a bend in the road the rear tyre sunk into unstable ground and the tray of the truck tipped onto its side.

There was minor damage to the ADT and no-one was injured.

1. Operators, including contractors, are trained and assessed as competent to operate mobile equipment. This needs to include model/equipment specific training and assessment.
2. Contractor management processes include verification of training and competency of operators.
3. Regular workplace inspections are conducted to identify unsafe behaviour and other activities that could put workers at risk of harm.
