NZ Safety Alert

28 March 2024

Hose releases from pump

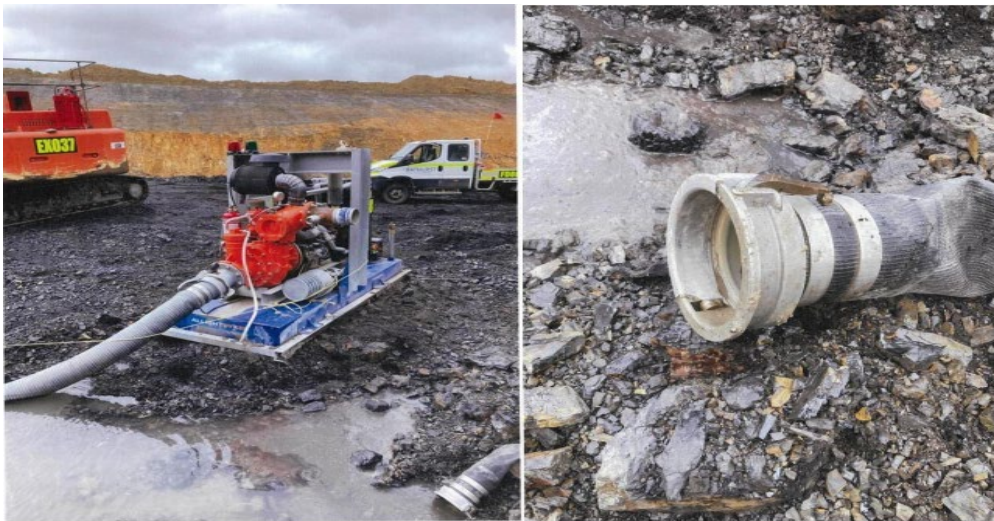
A worker received injuries to his head when he was struck by a camlock fitting attached to a layflat hose when the hose released from the diesel pump under pressure.

1. All diesel pumps are fitted with relief valves at discharge.
2. Where appropriate, whip chains/straps or other protection devices are used on pressurised hoses to secure them in the event of separation under pressure.
3. Pressure release hazards are identified and appropriate controls are implemented.
